# **Lye Valley: The Made-ground Bank to the east of the Warren Meadow off Warren Crescent.**

## **A study for Friends of Lye Valley (FoLV)**

J A Webb, February 2021

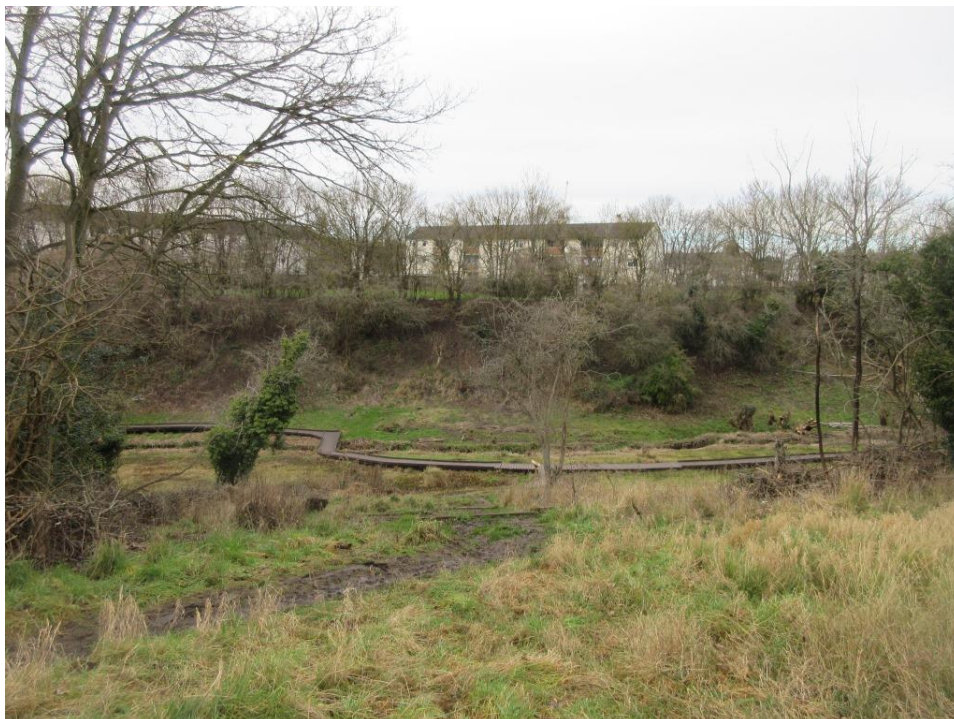
**Photo 1.** View from Peat Moors footpath across the valley to the tipped embankment and existing houses on Warren Crescent visible through trees. 21.01.2021

Below the houses is a line of field maple trees (hedge 26) which was planted at the break of slope (cliff edge) on the top of the tipped embankment of made ground. The embankment has a growth of bushes and slopes down to green area of old fen peat below (now dry) above boardwalk path and Lye Brook.

The Warren Crescent 10 house development has a SUDS swale designed and it will go along a 50m stretch in the made ground area between those existing houses and the line of trees at the top of slope (see plan of development). The edge of the swale on current plans would seem to be within 3m of the break of slope (cliff edge).

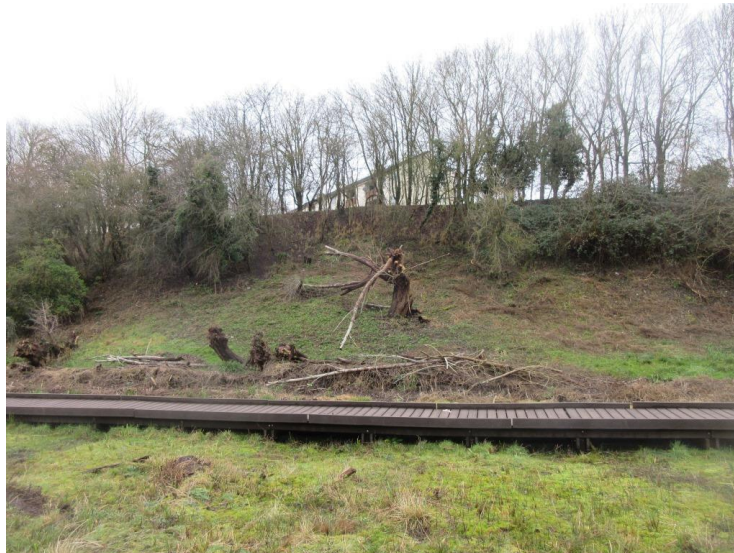
**Photo 2.** A little further north, view from Peat Moors bank of a big historic made-ground slump down the bank below the Warren Meadow.

This shows an old slump (landslip) A 40-50 yr old collapsing willow pollard is growing in the middle of it, presumably planted after the event, or surviving the event when it was a young tree. The slump extends all the way to the actual brook bank (where all the twigs and brash are next to boardwalk, see next photo as well). The clay and rubble material is covered in nettles, all historic original fen area on that side is buried and inaccessible - no fen restoration possible. This slump actually buries the line of a 22.5cm Thames Water sewer and an inspection hatch (Manhole no. 5904) which must be located just to the left of the collapsed willow (from map supplied to FoLV by Thames Water). Existing houses of Warren Crescent visible through trees at slope top. The headwall of the Swale will start at the point level with the nearest house beyond the trees.

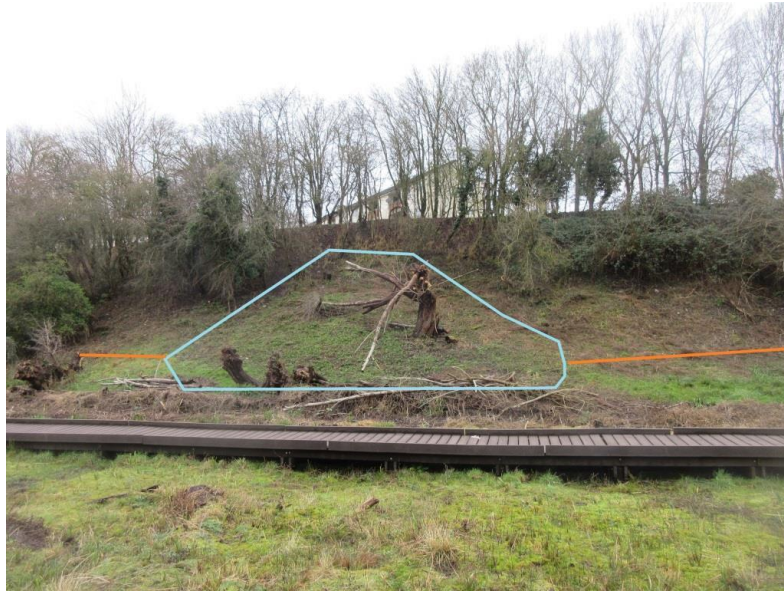
**Photo 3.** *Because the slump is not clear in the above photograph 2, here it is again with the limits of the old slump area out lined in blue, about 30m extent alongside the brook margin,.*

The orange line indicates the base of the rest of the tipped bank extent above a zone of dry old fen next to the brook margin (indicated by all that brash). Because of the slumping, the majority of this slope is now a shallower (more stable) slope angle than the rest of the bank, except at the very top of the slope where there is a steep 'cliff' of material that did not move (above top of blue line). It is impossible to tell if there was/is still a spring under this slumped area which might have been the cause of the material moving downslope.

My survey identifies a historic slump/slide of material down the bank and all the way to the Lye Brook. This likely happened fairly soon after the tipping whilst material was loose. Since then it will have settled and consolidated. The large willow tree growing out of it indicates it happened a long time ago. Likely the trees of hedge 26 were planted in the 1970s when much dumped (fly tipped) material was removed from the valley and a fence erected at the edge of the slope to stop any more of such activity. That makes the biggest of the trees (field maples) in that hedge 40+ years old. Their roots will be holding the top of the bank at the edge together, other trees and bushes on the slope will assist in stability.

This historic slumped area was not identified in a bank walk-over by the firm Geotechnical Engineering for the housing contractors R.J. Leighfields in a recent commissioned study of ground stability in the made ground. Whilst an old feature, it does demonstrate that a landslip can occur with the 8m depth of made ground at the east edge of the development site.

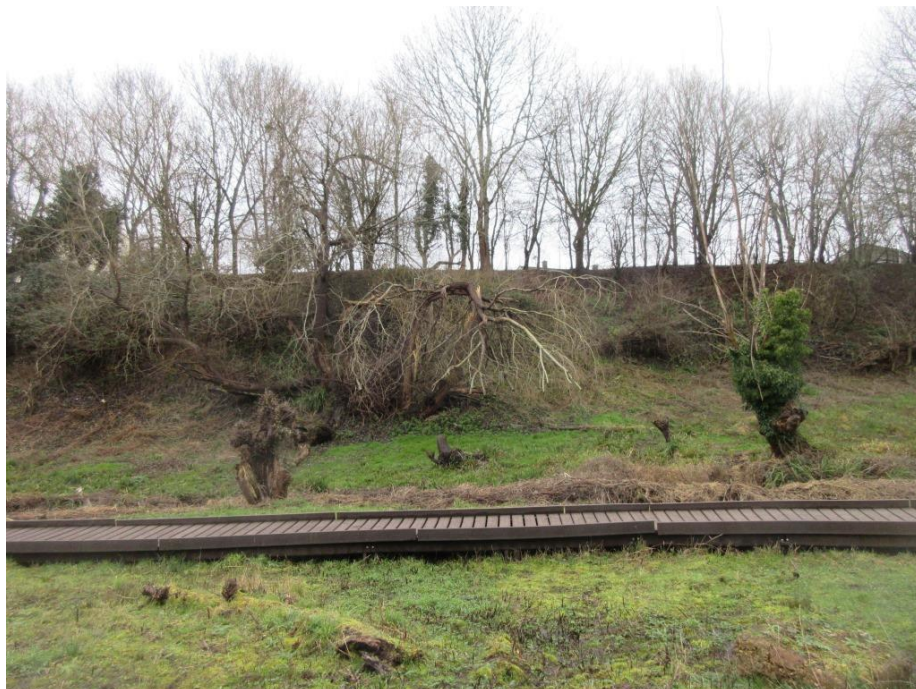
**Photo 4.** *Further north, beyond cut willow pollards on the brook bank. In view is a big old multi-stemmed collapsing willow growing out from the base of the tipped bank,*

The large multi-stemmed collapsed willow might have been growing on the old spring line and survived partial burying by embankment material in the 1950s. A spring area is to its left (south) behind the pollard on the brook bank. Old fen is being restored below it in a narrow green strip (5-6m wide) on the other side of the brook. Note the Warren Crescent new housing will go on the green area above this section of bank beyond the trees at top. How far houses from the cliff edge? – from the plans, estimated 9 metres at nearest.

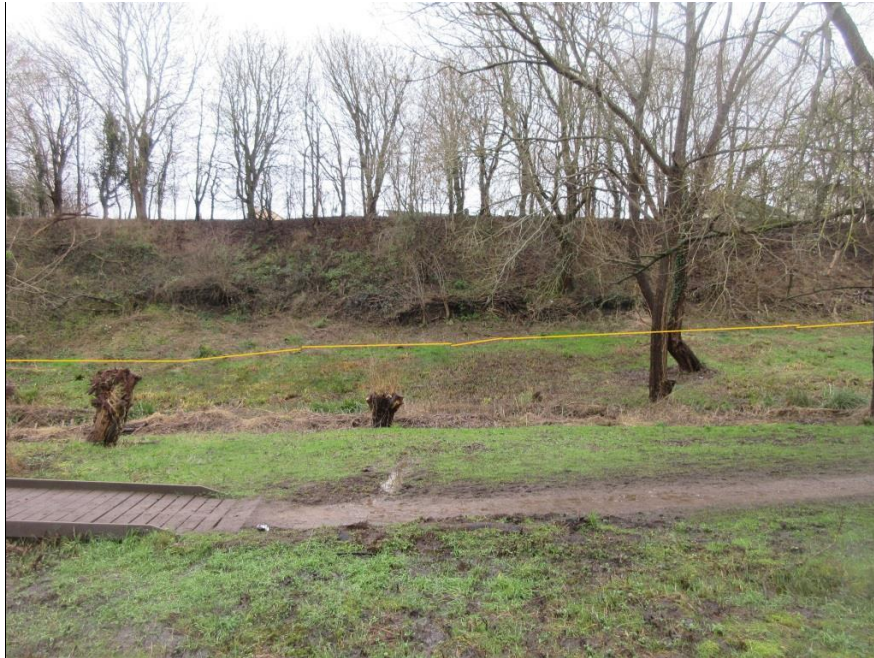
**Photo 5.** Further north again, almost at the interception ponds (off to right of photo). Opposite the beginning of the boardwalk.

Below the bank here on the far side of brook there is good spring flow with wet peat and several valuable tufa-forming springs emerging from below the base of the bank (junction of made ground with fen indicated by yellow line). This wet area is being targeted for fen restoration cutting by FoLV (scything, raking and seeding in a 9-12m wide section). Those two big crack willow trees growing out of the fen on the right will eventually be felled and their trunks used for a really big leaky dam at the outflow of the lowest interception pond. The tipped bank above is particularly steep here – above this fen zone is where the 42 degrees slope angle was measured. Warren Crescent new housing will go above this section of the bank, maybe 20m back from the cliff edge.
