Lye Valley SSSI North Fen

Vegetation Transect investigation of the drying effect of brook bank erosion

North Fen SSSI unit 1

Collected by Dr Judith A Webb

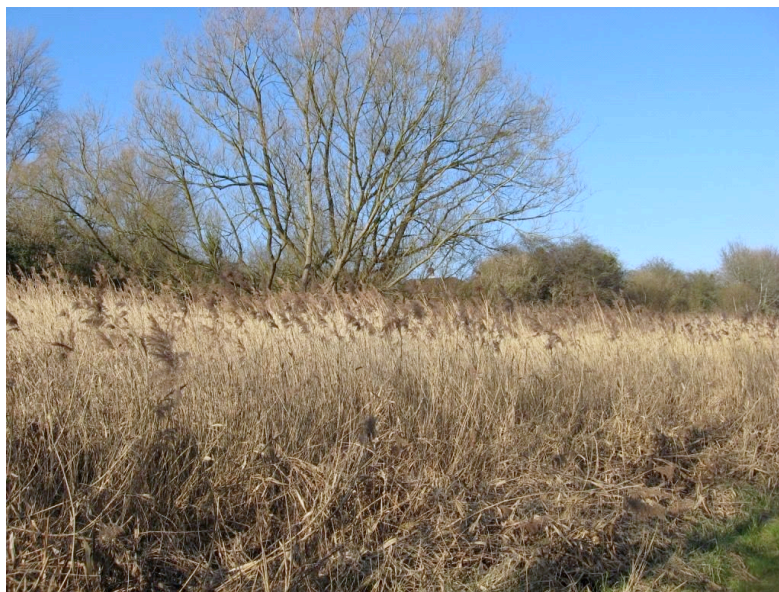
West side of fen, ex-arson area adjacent to path, uncut for many years and progressed to reed monoculture

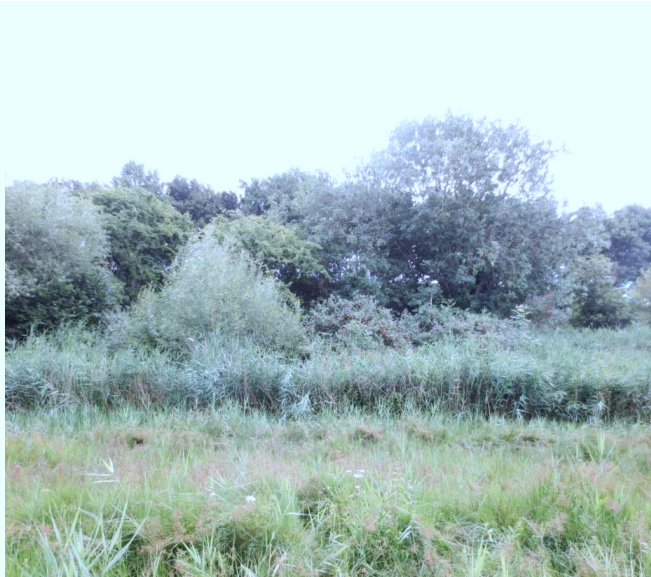
Site 1 transect position in centre of photo. Looking from brook across fen to spring line at edge of reeds and dry valley side with trees above

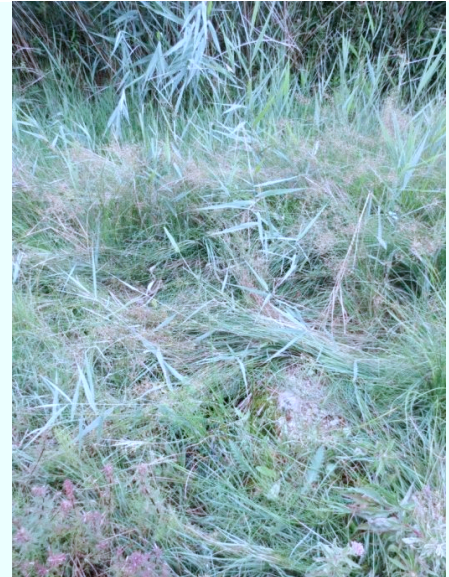
Start of transect 0m next to concrete lump at spring line, reed and blunt-flowered rush

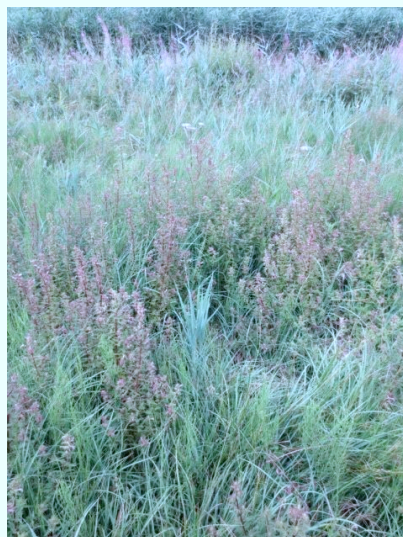
Middle section of transect. Wet area with marsh lousewort prominent in vegetation.

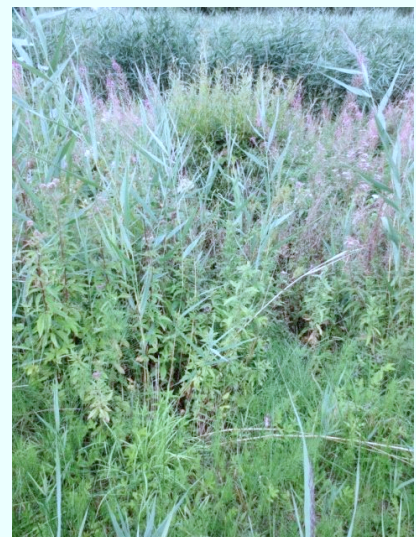
End of transect 16m at brook bank. Tall herb vegetation on dry peat in front of pollard willow.

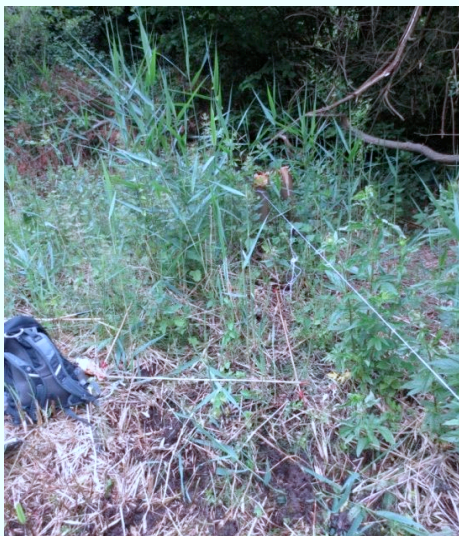
Transect start 0m at break of slope just in front of willow stump

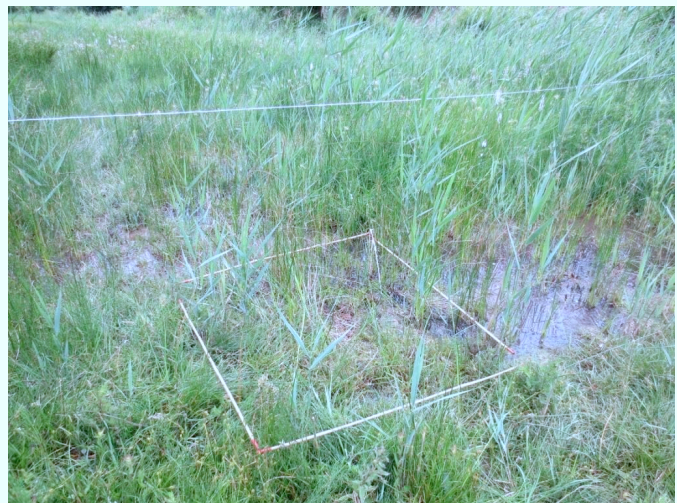
Middle of transect at 7m, short low nutrient fen vegetation and mossy tufa pool with stoneworts.

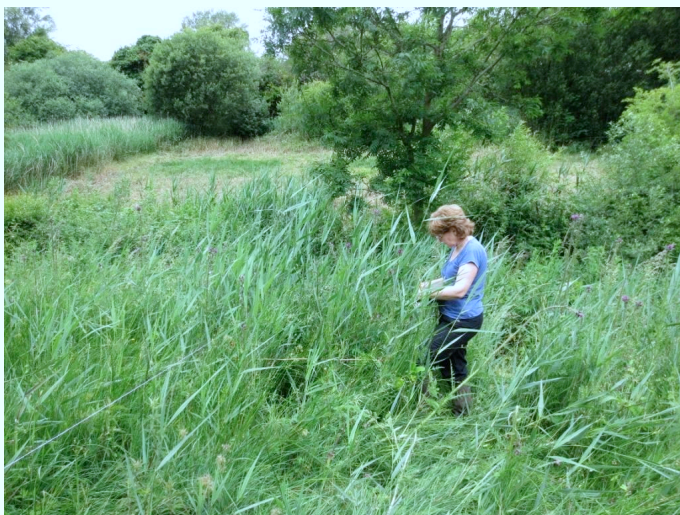
Approaching brook-side at 11-12m, recording in drier peat, vegetation here tall reed and dense blunt-flowered rush.

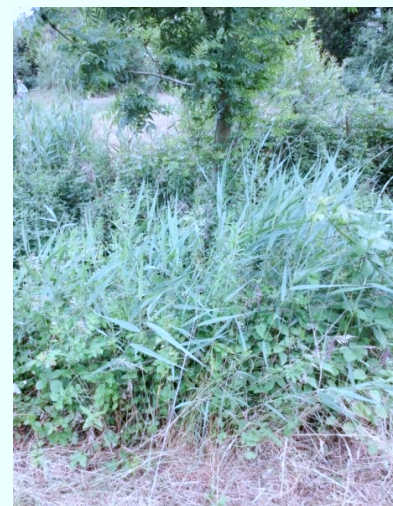
End of transect at 15-16m, cut path and tall herb vegetation and dry land plants opposite young ash tree.

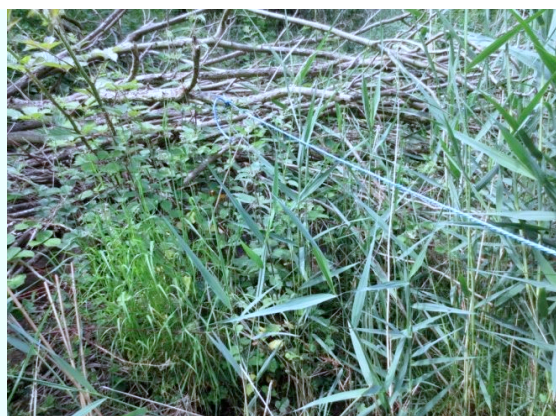
Start of transect top of slope at Newly-coppiced ash tree 0m

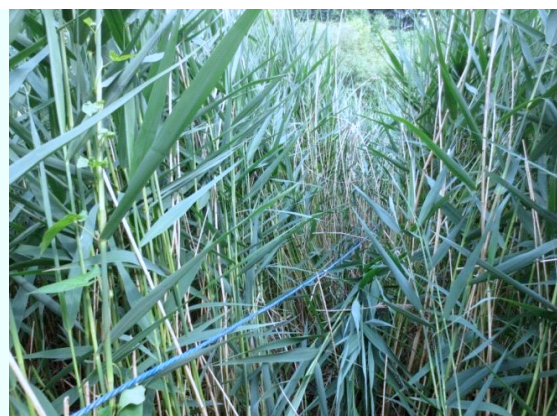
Looking down transect from start at ash tree, dense reed dominated area, no previous cutting and raking history.

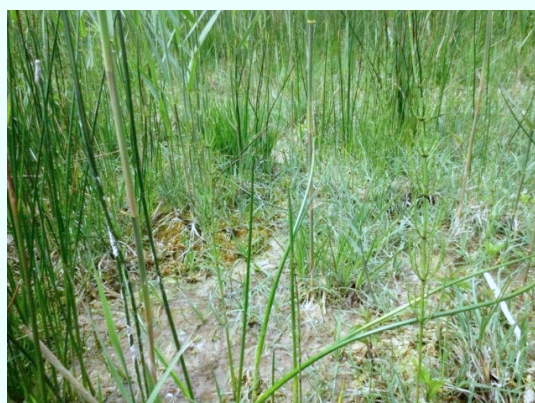
Middle section of transect, more open and diverse, tufa area, not reed-dominated, previous cutting as fire-break

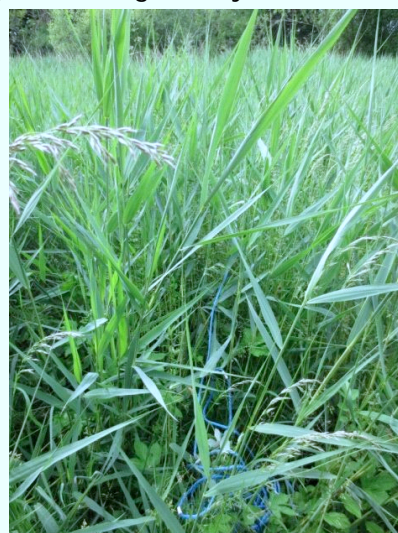
Bottom end of transect, looking up from boardwalk through reed-dominated area (arson attack in 2006).
