Comment by Friends of Lye Valley (FoLV) on :

**Re: Geotechnical Engineering, WARREN CRESCENT, HEADINGTON, OXFORD  
SLOPE STABILITY APPRAISAL, Report Ref: 36045 for by R J Leighfield & Sons Limited  
Date 09/10/2020. (Document achieved by Freedom of information request.)**

[For development at Land East of Warren Crescent, Oxford, **OX3 7NQ**. original application 13/01555/CT3 *Erection of 10 x 3-bed dwellings (use class C3) together with associated car parking, cycle and bin storage. Diversion of public footpath. (Amended plans and description)*]

**21.02.2021**

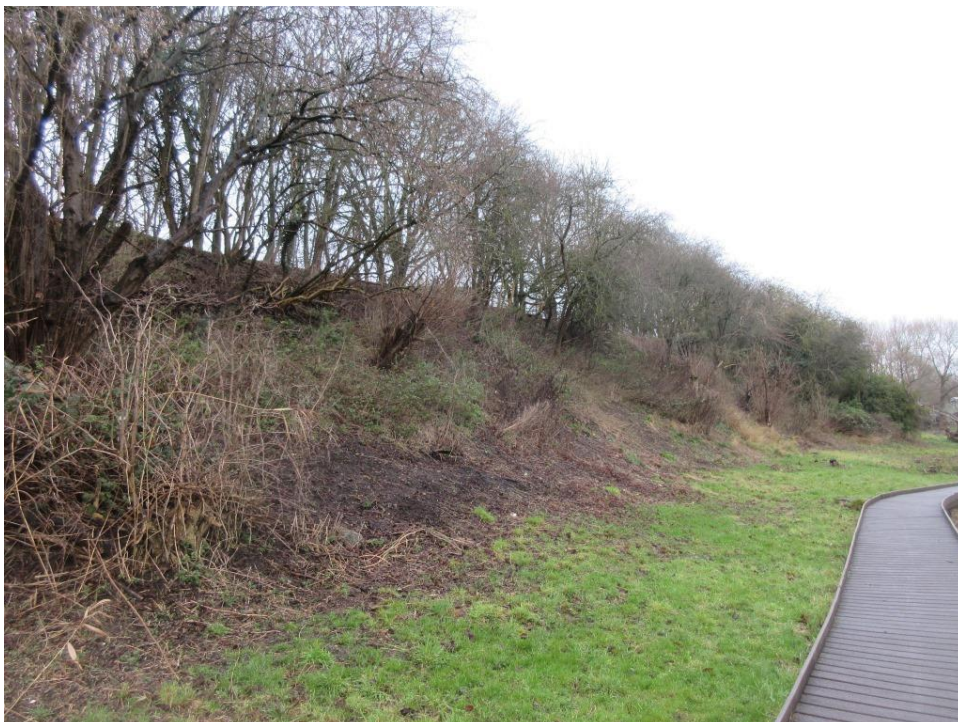
*13.01.2021 J.A.Webb*

*Tipped embankment of made ground (left, slope angle 32 to 42 degrees) to the Warren Crescent site at top left behind the trees. View looking north from the boardwalk through fen in Lye Valley bottom.*

**FoLV have serious concerns that excavations for foundations of these 10 houses and associated infiltration SUDS of a long narrow Swale in the depths of made ground on a tipped embankment with a very steep slope down into the valley will lead to the destabilising of this embankment.**

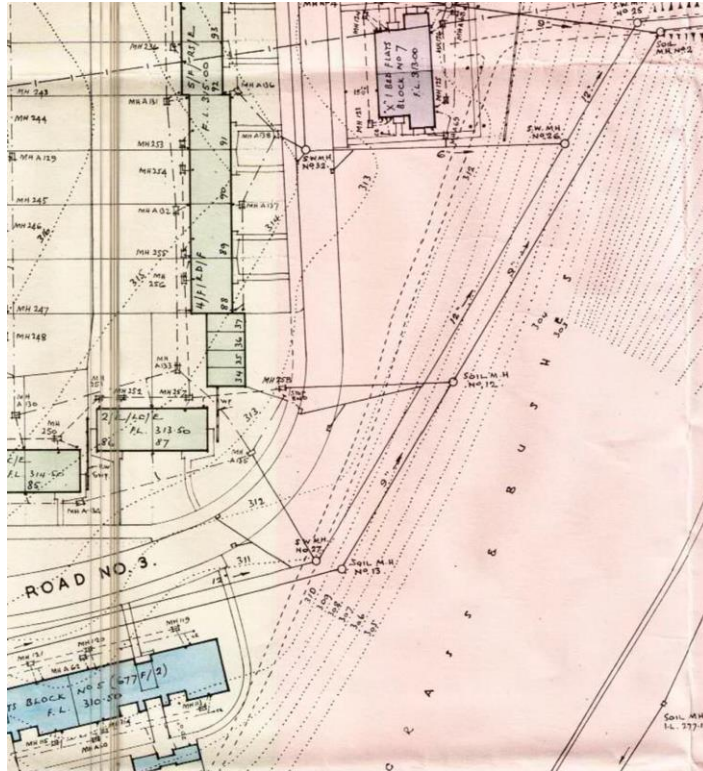
Extract from the 1954 plan for the Town Furze estate. Road 1 =Warren Crescent. Current 10 house development planned to the right of bend in the road at dead centre. Contours show natural geology Beckley Sands slope now buried under made ground tipped on the slope after the estate housing was constructed.
