Work on the Interception Ponds at the head of Lye Valley and structures in the Lye Brook October 2020

J A Webb, Friends of Lye Valley

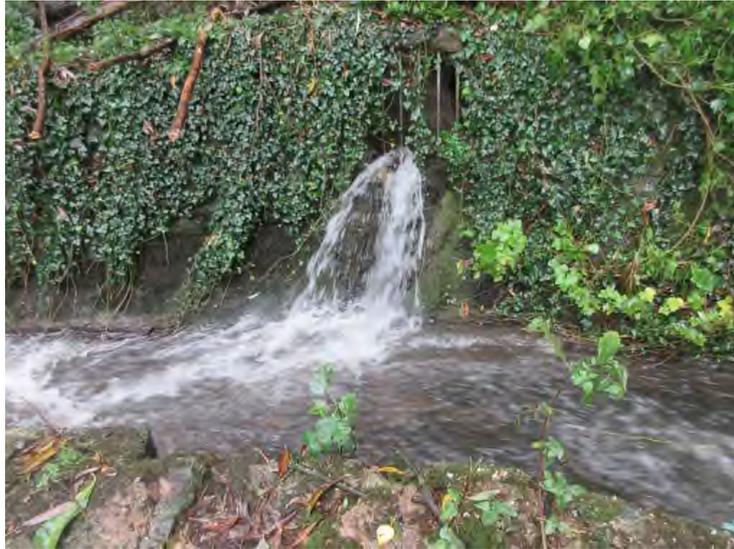
The Lye Brook receives a large volume of road run-off water from a couple of storm drains which enter at the head of the valley. This input started in the 1920s and gradually increased as housing estates were built, eventually surrounding the north end of Lye Valley. The resulting flash-flooding from drains after rain caused brook banks of soft peat to erode and the brook base was deeply gouged down, drying out and damaging the rare calcareous alkaline fen habitat next to the brook.

Storm drains emitting road run off at head of the valley after heavy rain Oct 2020

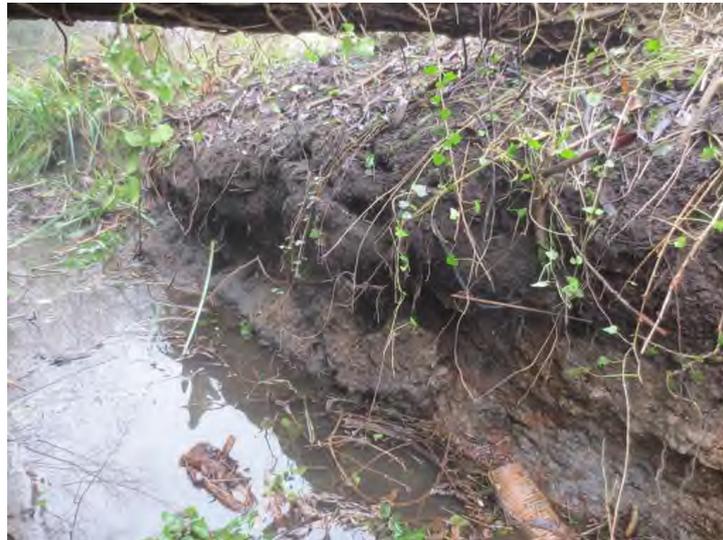
Bank erosion showing loss of peat, 2017

With further city development around the valley this erosion was very serious by the late 1970s. In the 1980s grant funding to Oxford City Council for a number of mitigation actions to reduce damage was achieved from Thames Water. These actions include digging out two ponds within the brook with two log-paling weirs at the pond exits at the head of the valley. These were to hold back some run-off water and this is how they looked when newly dug.

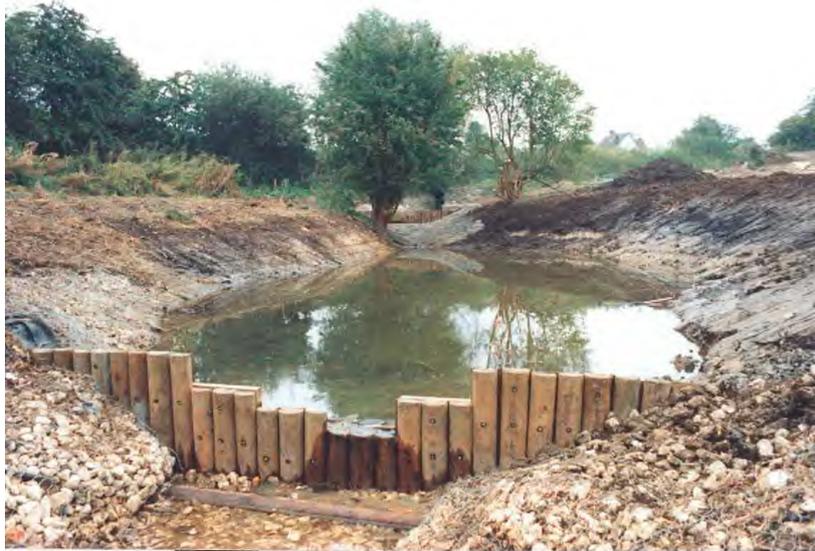
*View up the valley showing the lower of two ponds newly dug, October 1988.
Thanks to Oxford City Council archive for this image.*

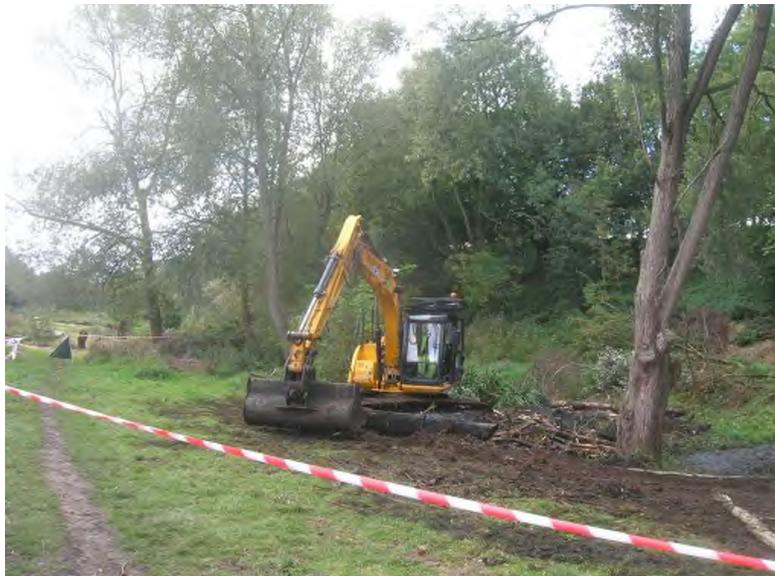
Unfortunately, since 1988 the ponds have gradually been filled up with silt from roads such that they cannot actually hold any water back. They were never dug out. In 2017 a further grant from Thames Water of £10,000 was received by Oxford City Council to de-silt the ponds again, the phase 1 of further mitigation and remediation actions.

Digger begins work 30th Sept 2020, phase 1

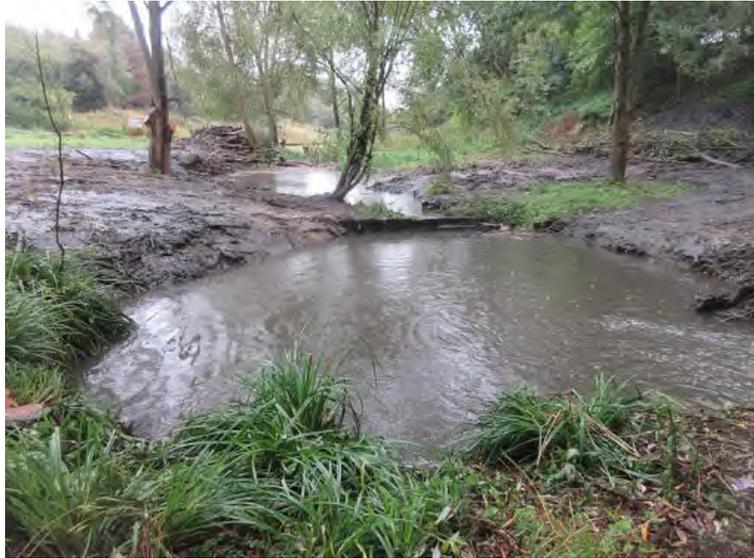
*Ponds after de silting (looking down the valley)
1st Oct 2020*

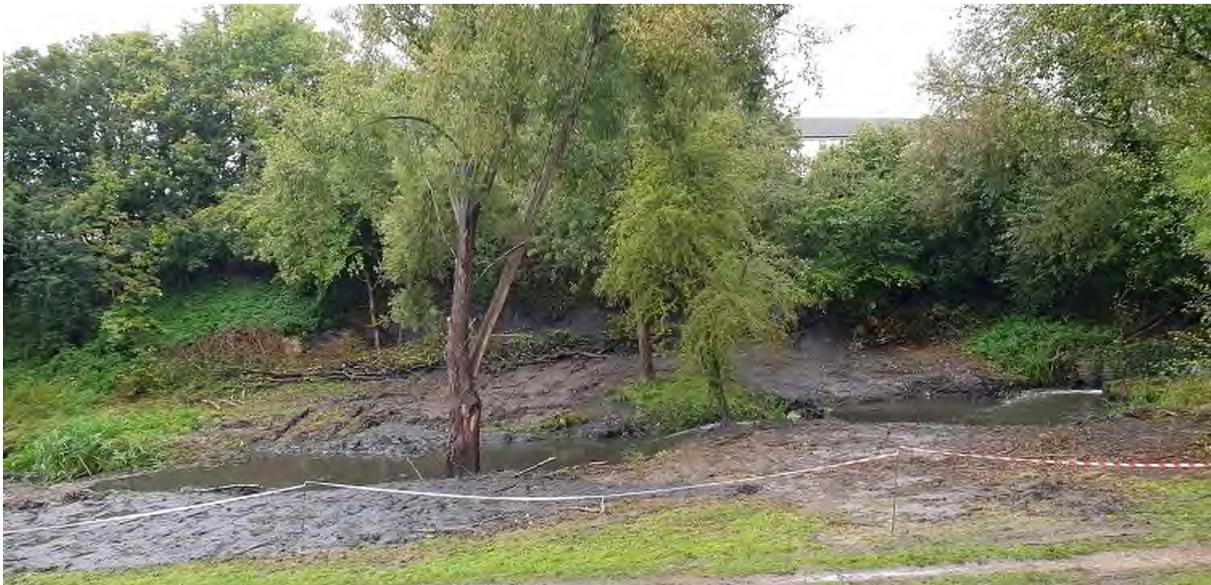
*Overview of pond de-silting works from the footpath 1st Oct 2020
Photo T Newsome*

The heavy rain on Friday 1st Oct 2020 meant the digger could not complete all the silt removal from the lowest interception pond. We understand this can be completed within the grant budget another time over the next month. Now we are beginning the re-seeding of all that bare damaged peat and mud chewed up by the heavy digger.

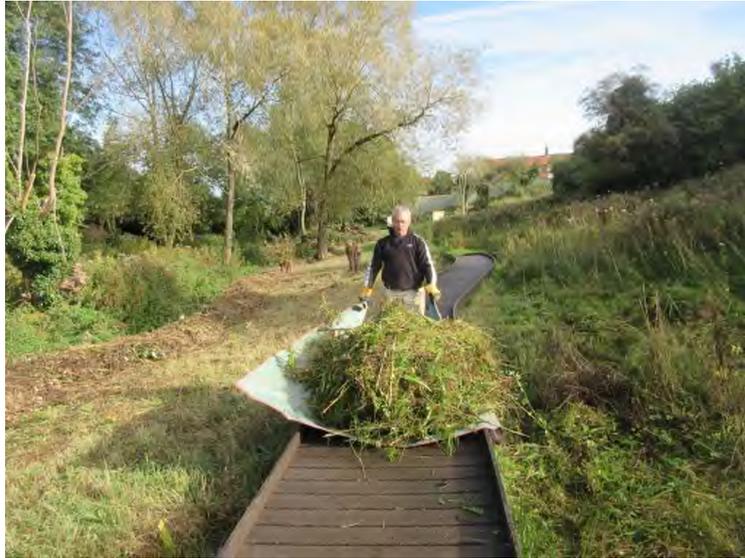
Dragging the green hay cuttings to spread over the chewed up bare peat left by the digger

Seed will drop from the many species in the hay to green up this damaged area quickly next spring.

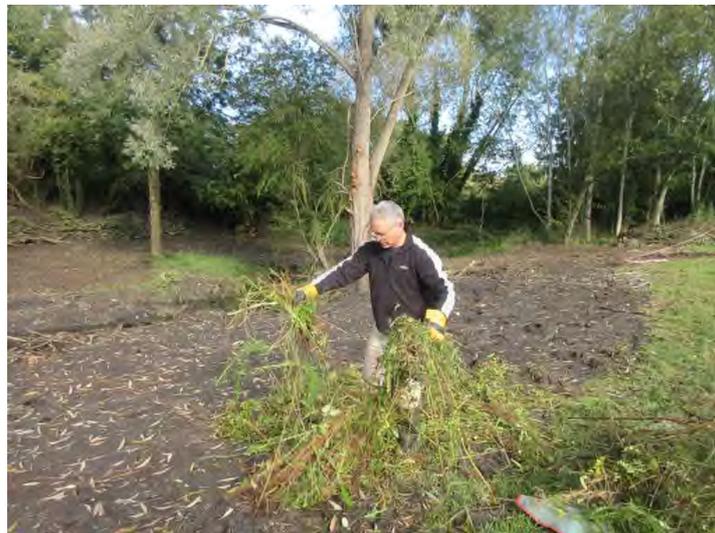
Spreading the green fen hay over the damaged area next to the de-silted ponds

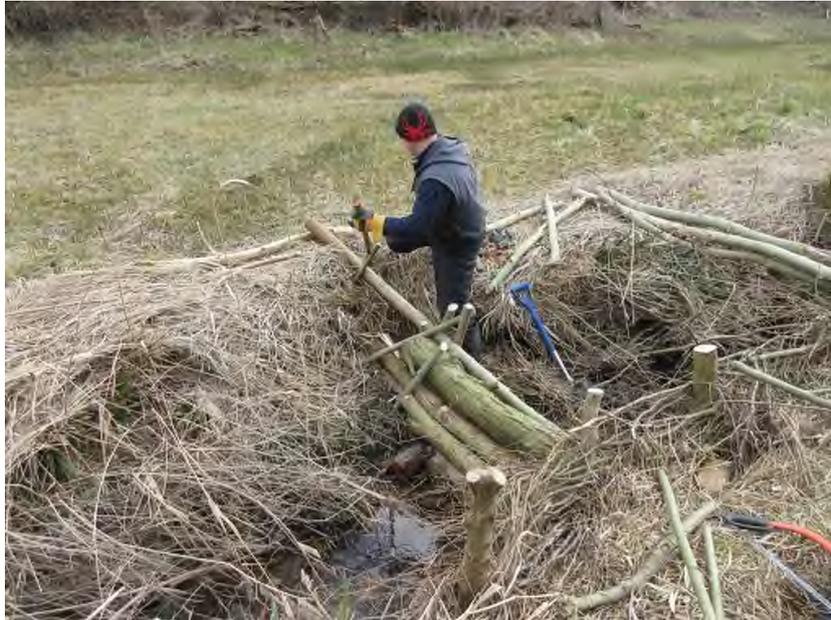
Further down in the Site of Special Scientific Interest (SSSI) fen section, the brook has been eroded down to more than a metre deep and soft peat was being lost from the banks, resulting in fen nearby being dry and damaged. Grant funding from Natural England enabled the installation of 19 leaky log dams to slow the erosive flows after heavy rain in this area. These went in during March 2018 and have been very effective in reducing the force and speed of run-off after rain, but more are needed. Ultimately, as Phase 3, FoLV hope flows could be slowed enough to raise the water level in the brook to re-wet the adjacent dry peat and restore wet fen next to the brook.

Leaky log dam installation in the SSSI section 20.03.2018

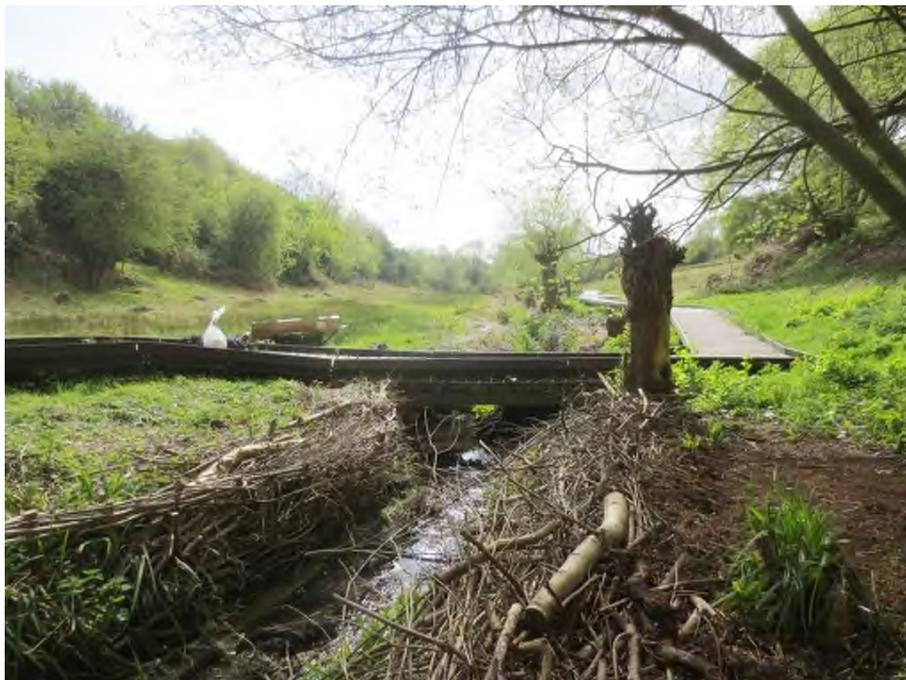
To stop further soft peat being lost from the banks these hazel wattle structures were made by FoLV volunteers to protect the banks from further erosion during high storm flows; but these flows really need to be reduced at source, by retrospectively re-greening the catchment, reducing hard surfacing.

Near the bridge, bank erosion has been stopped by installation of protective hazel wattle structures by FoLV volunteers.
