# ***Flood Alleviation and Stopping Erosion in the Lye Valley***

**By Rod d'Ayala, for  
Friends of Lye Valley, July 2024**

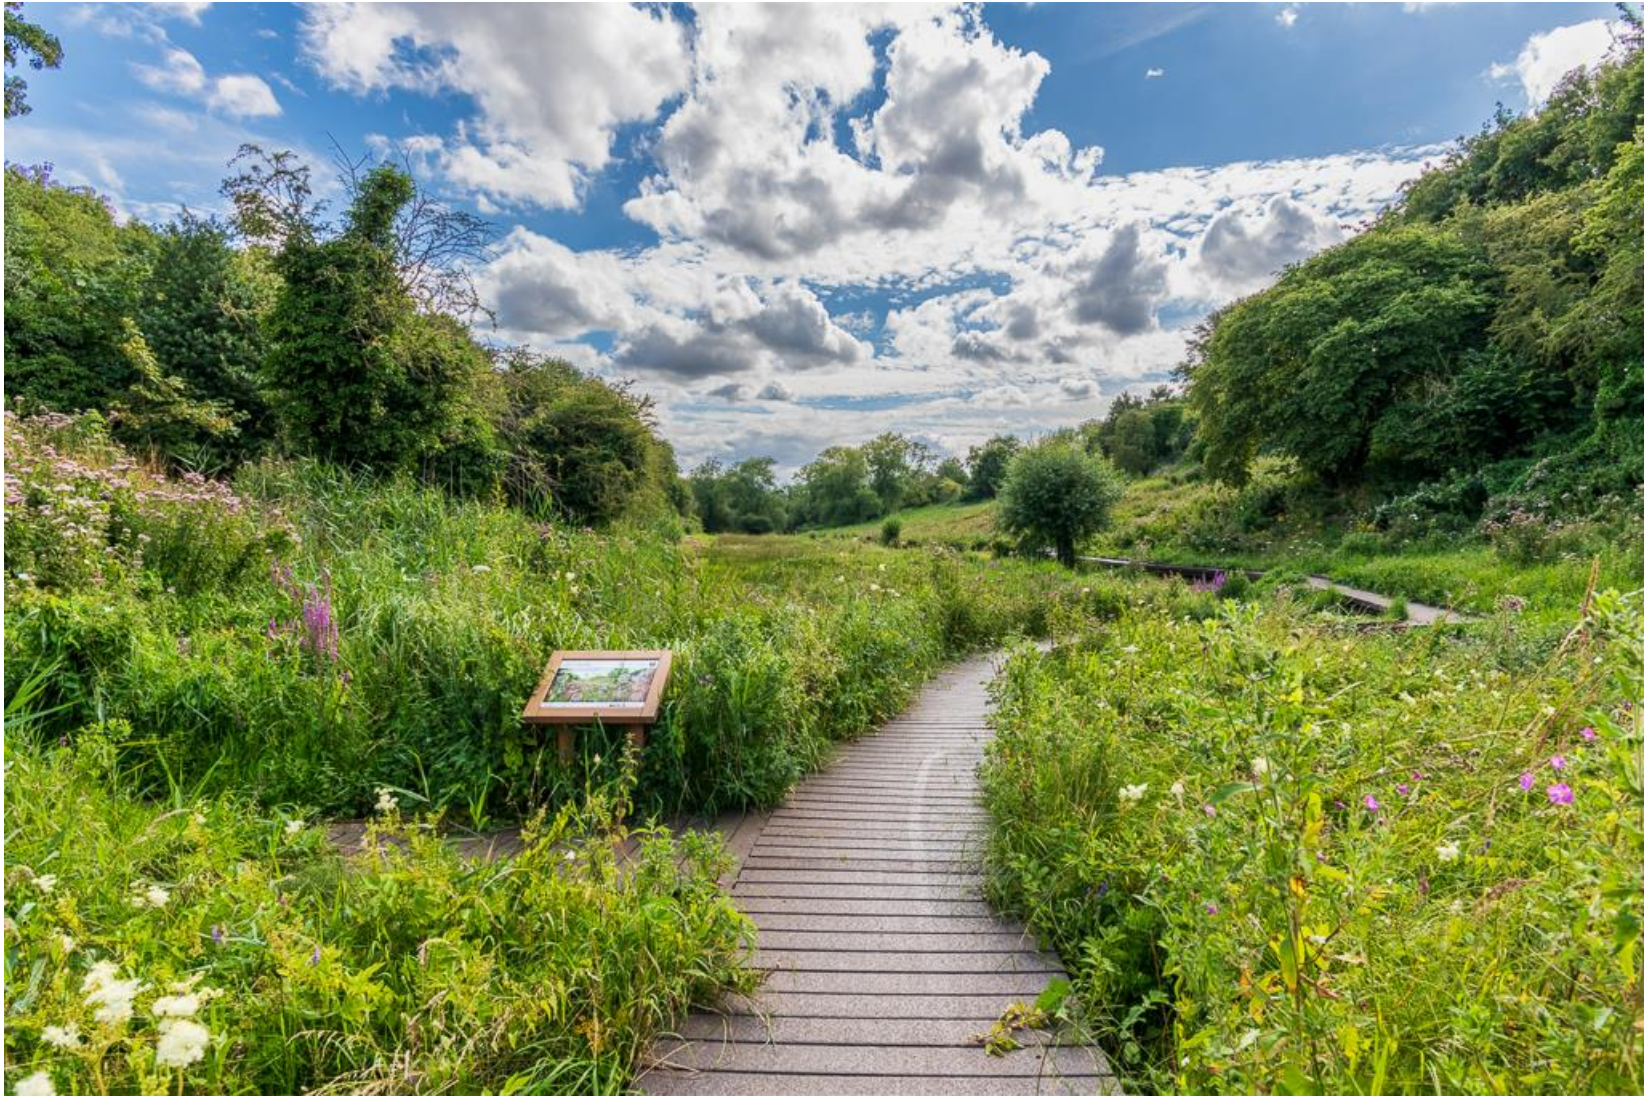
**The Lye Valley in North Fen SSSI section, mid summer. A spring-fed, alkaline, tufa forming valley-fen rare habitat on 1m peat**

Lye brook runs parallel to the boardwalk through fen centre and is deeply eroded (gouged-down) by intermittent high water flow

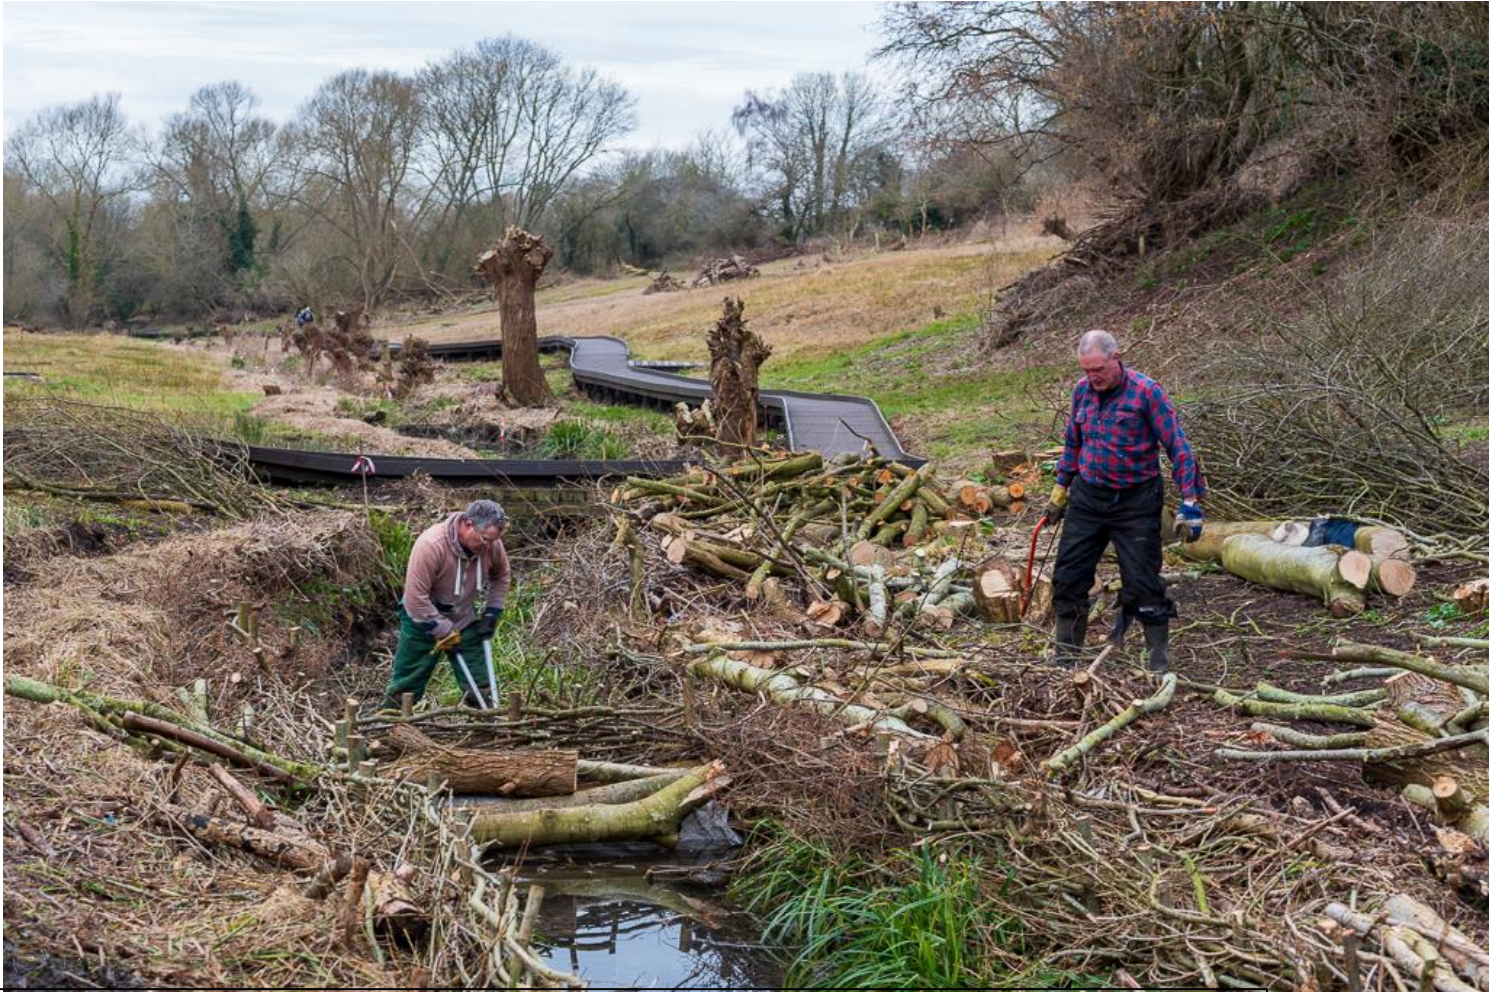
***Flash-flooding in the brook is a result of rain run-off from roads, paving, houses being directed from a large area of Headington into the small Lye Brook***

Volunteers constructing mitigation leaky log dams and bank defences in the brook channel. These slow peak flows and stop peat erosion

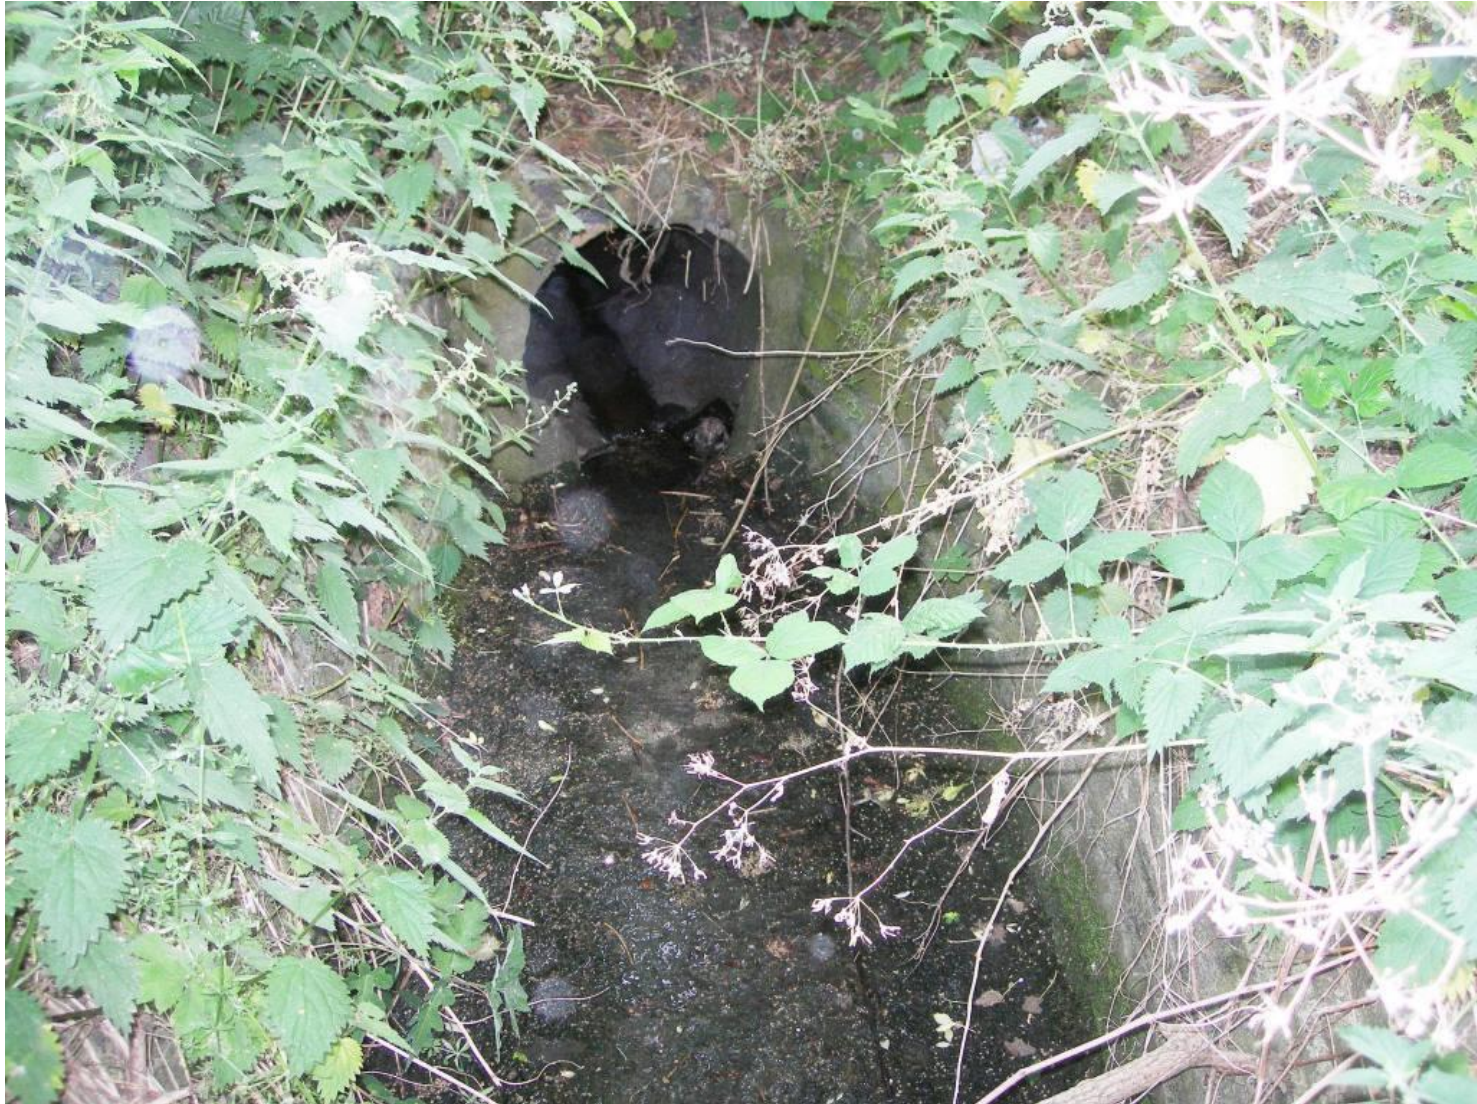
**The 60cm wide Thames Water road run-off drain at the head of valley drains Headington. In dry weather, no flow**

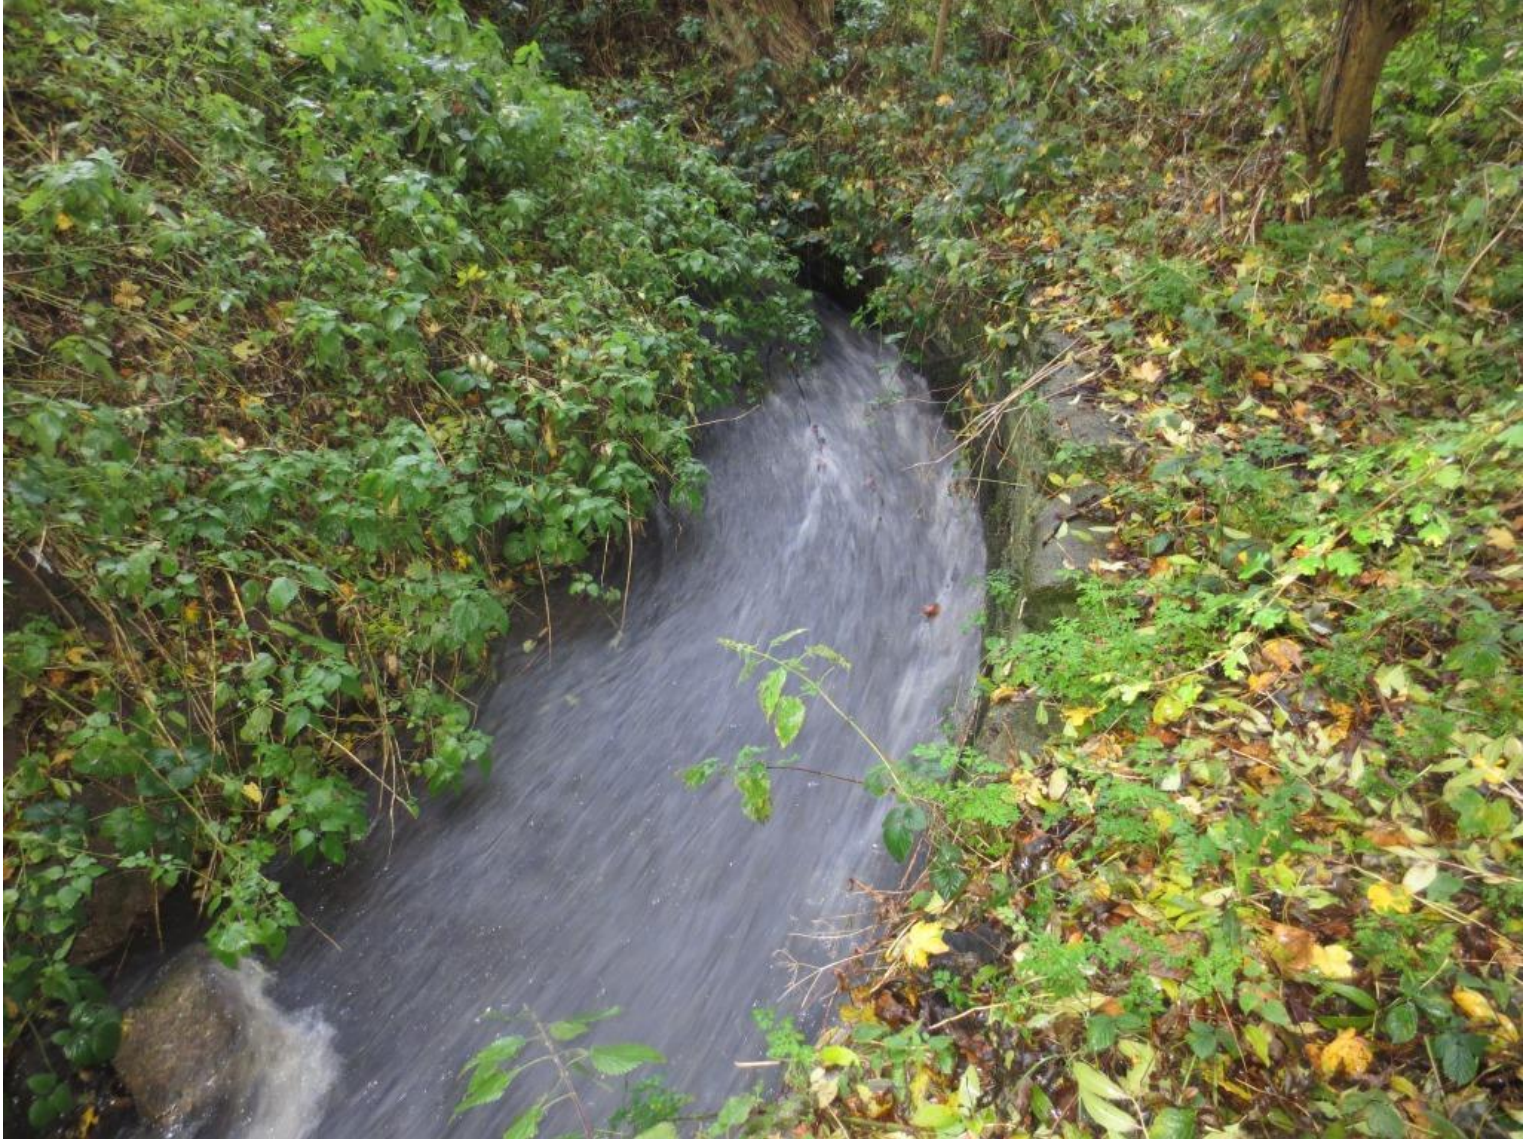
## Road drain emitting after a rainstorm, raging torrent

Peak out-flow after a rainstorm was estimated **1,750 litres per second** in 2011

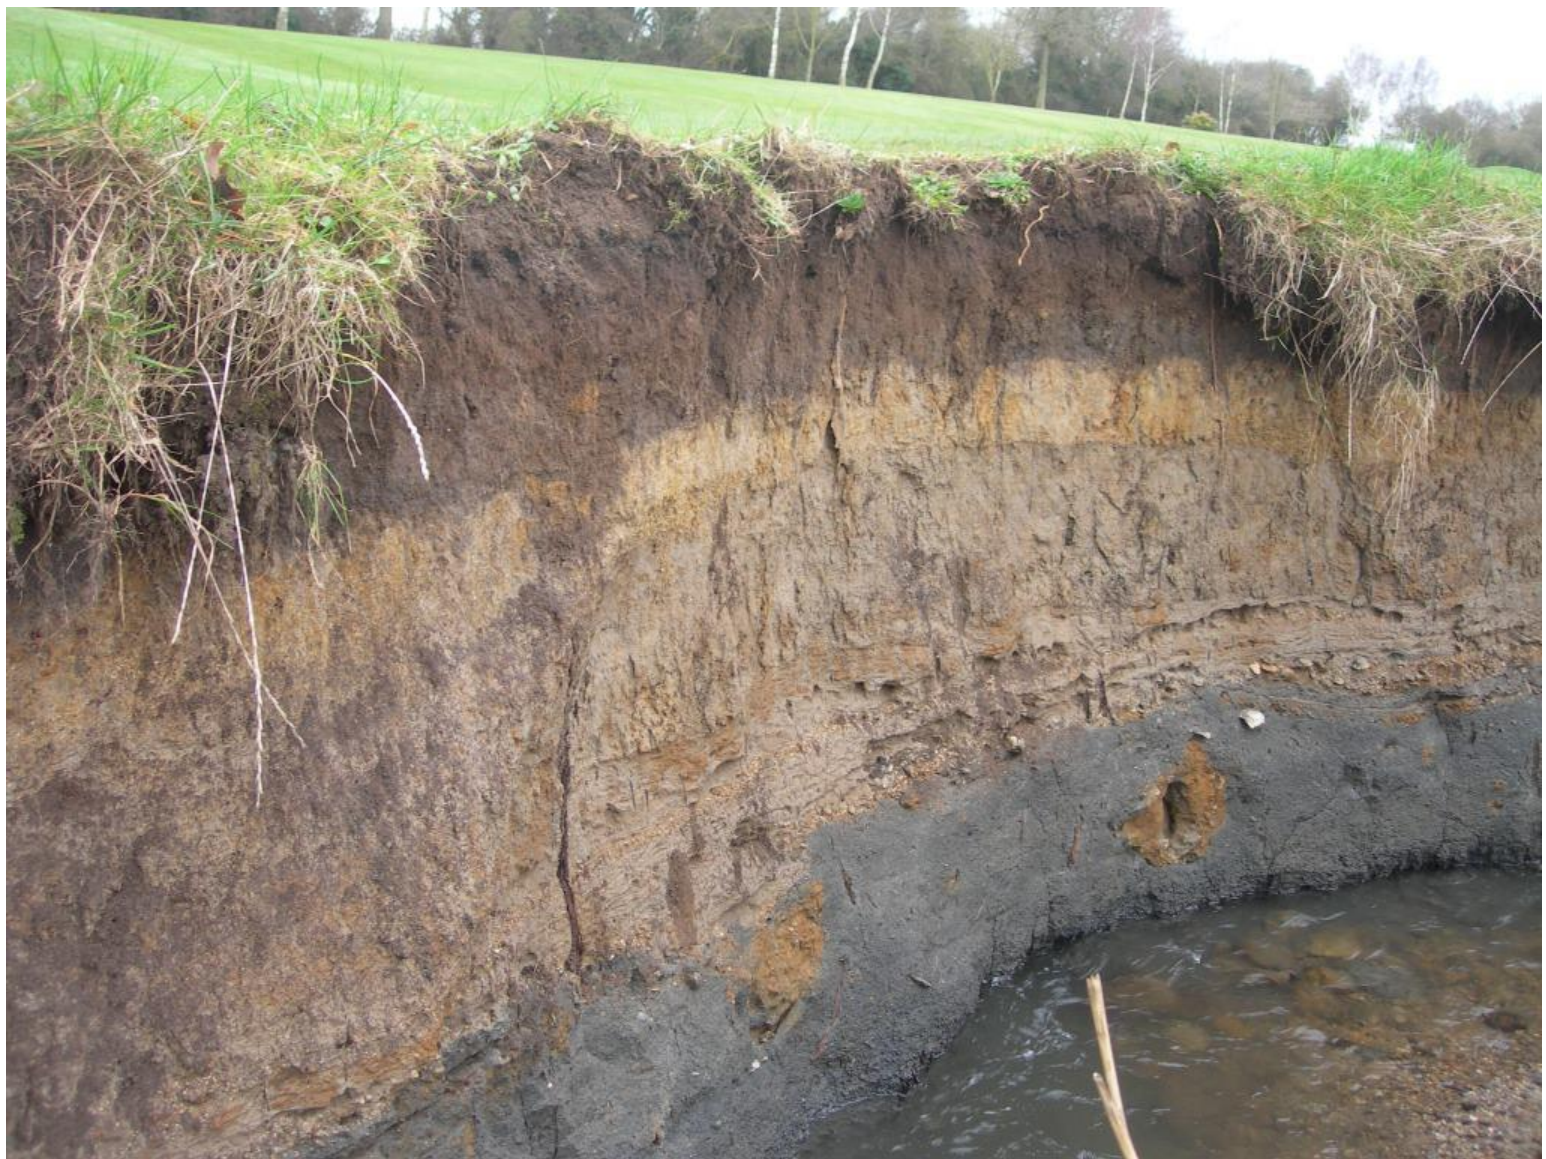
Depth of bank erosion in the Boundary Brook as it goes through the Golf course, 2011. Deeper now...

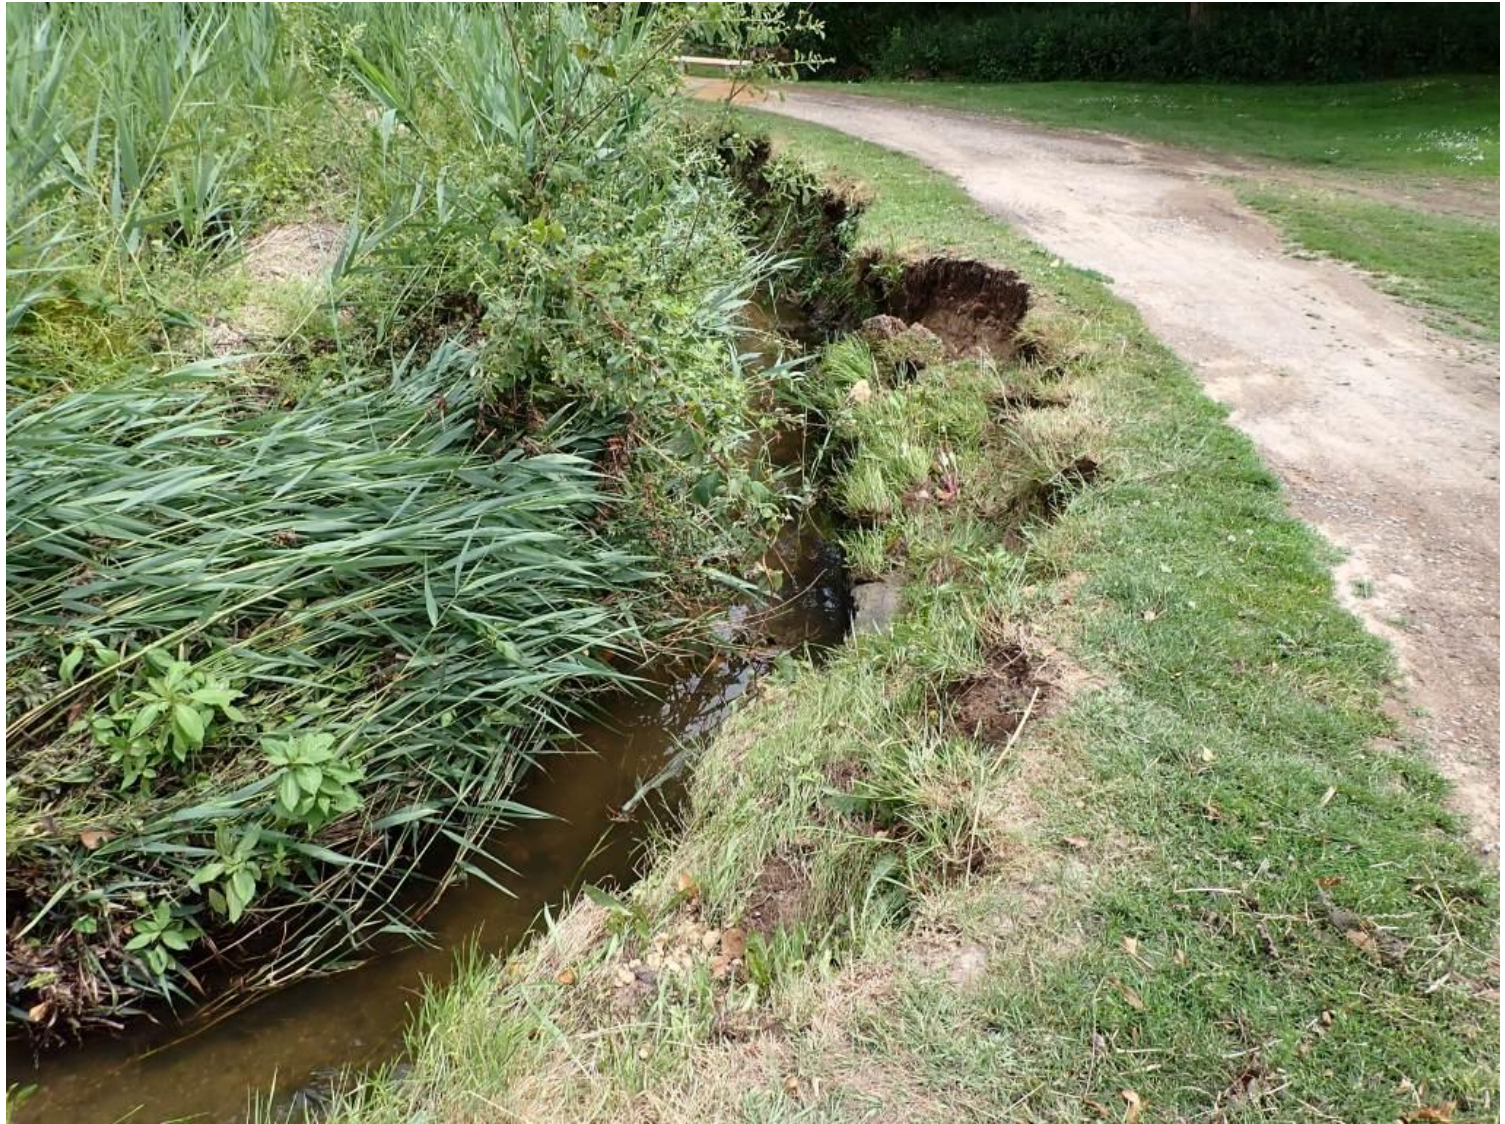
**Erosion and brook bank collapse along Lye Brook lower down in the golf course area next to the south fen part of the SSSI following 20<sup>th</sup> June 2023 rain-storm. Bridge damaged**

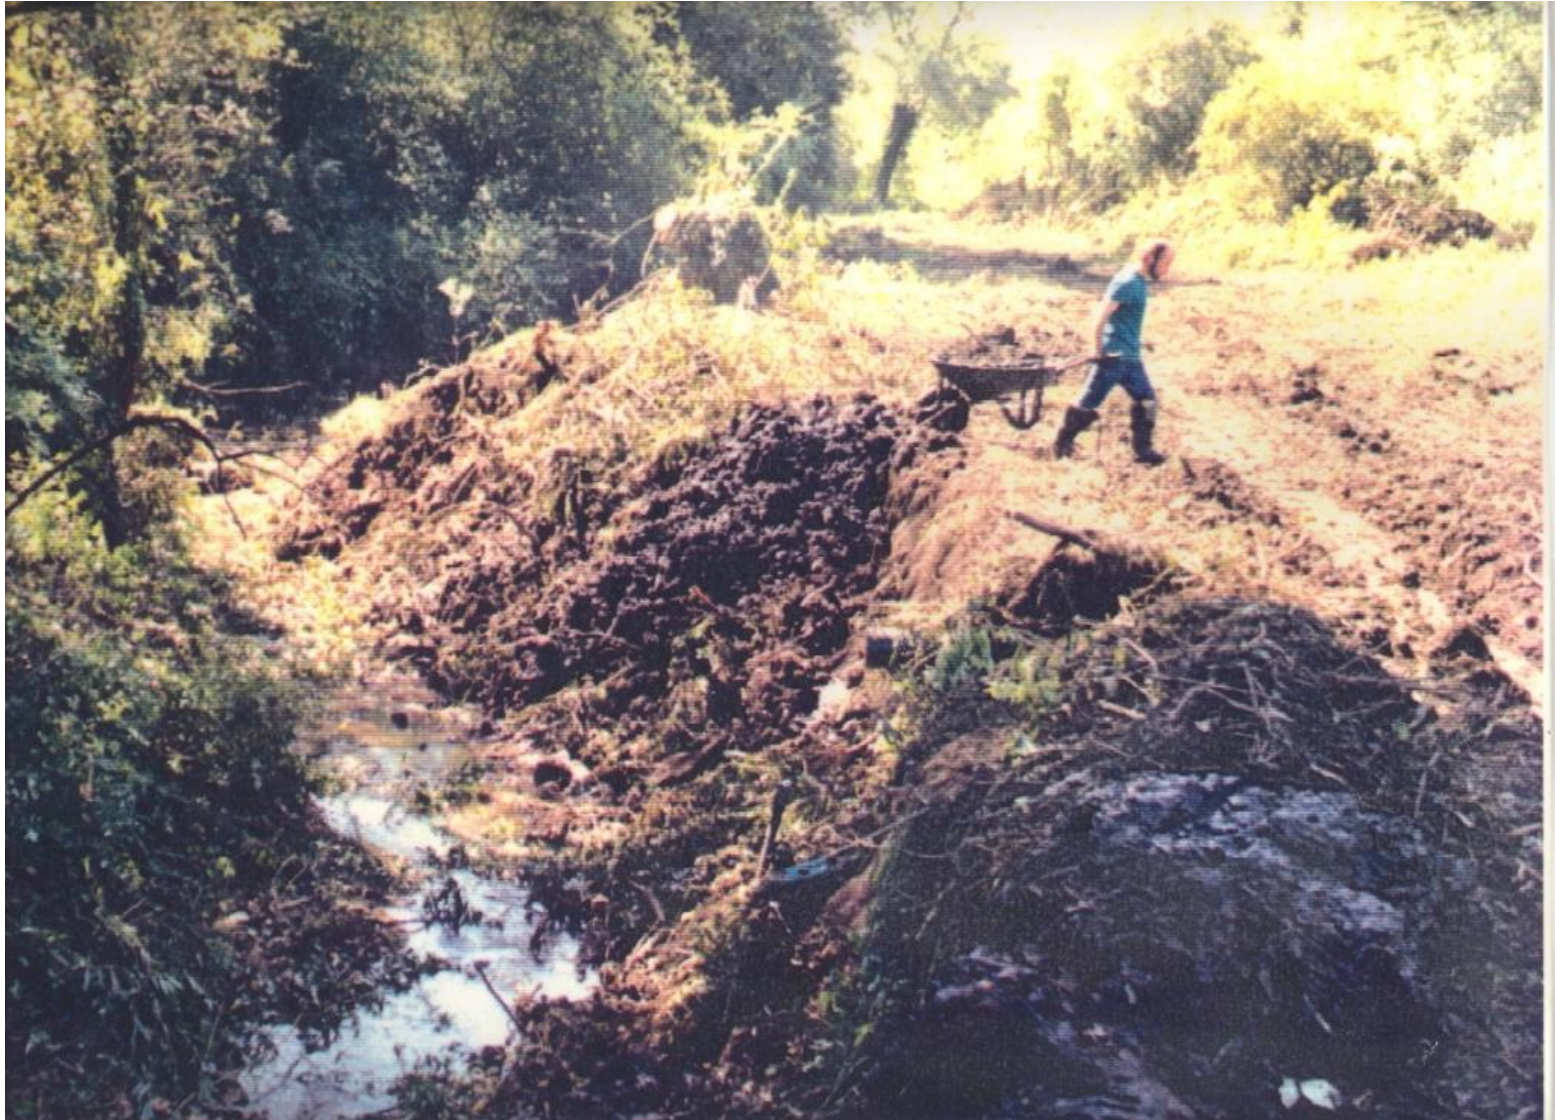
**The only photo we have of channel/fen erosion by the 1980s at the valley head, beginning of remedial work**

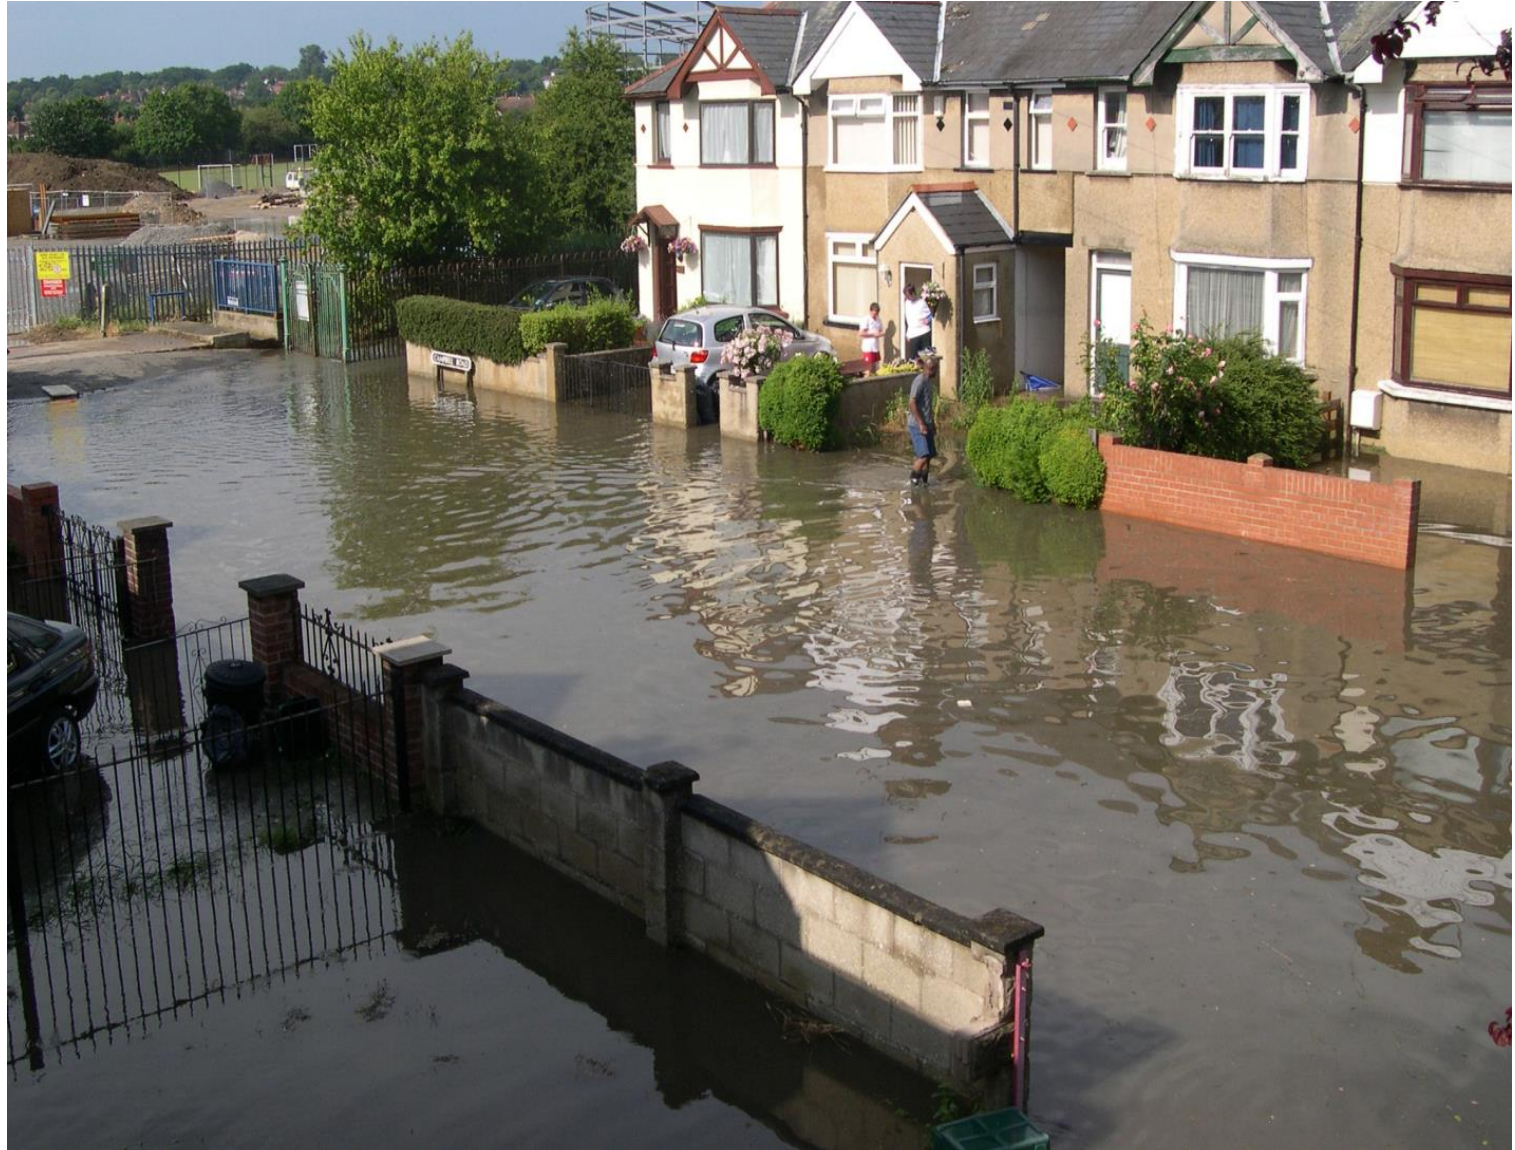
**Lye brook joins Boundary Brook. Flooding from this joint watercourse in the Florence Park & Campbell road area:**

Photo Martin Crane (resident) flooding in Campbell Road

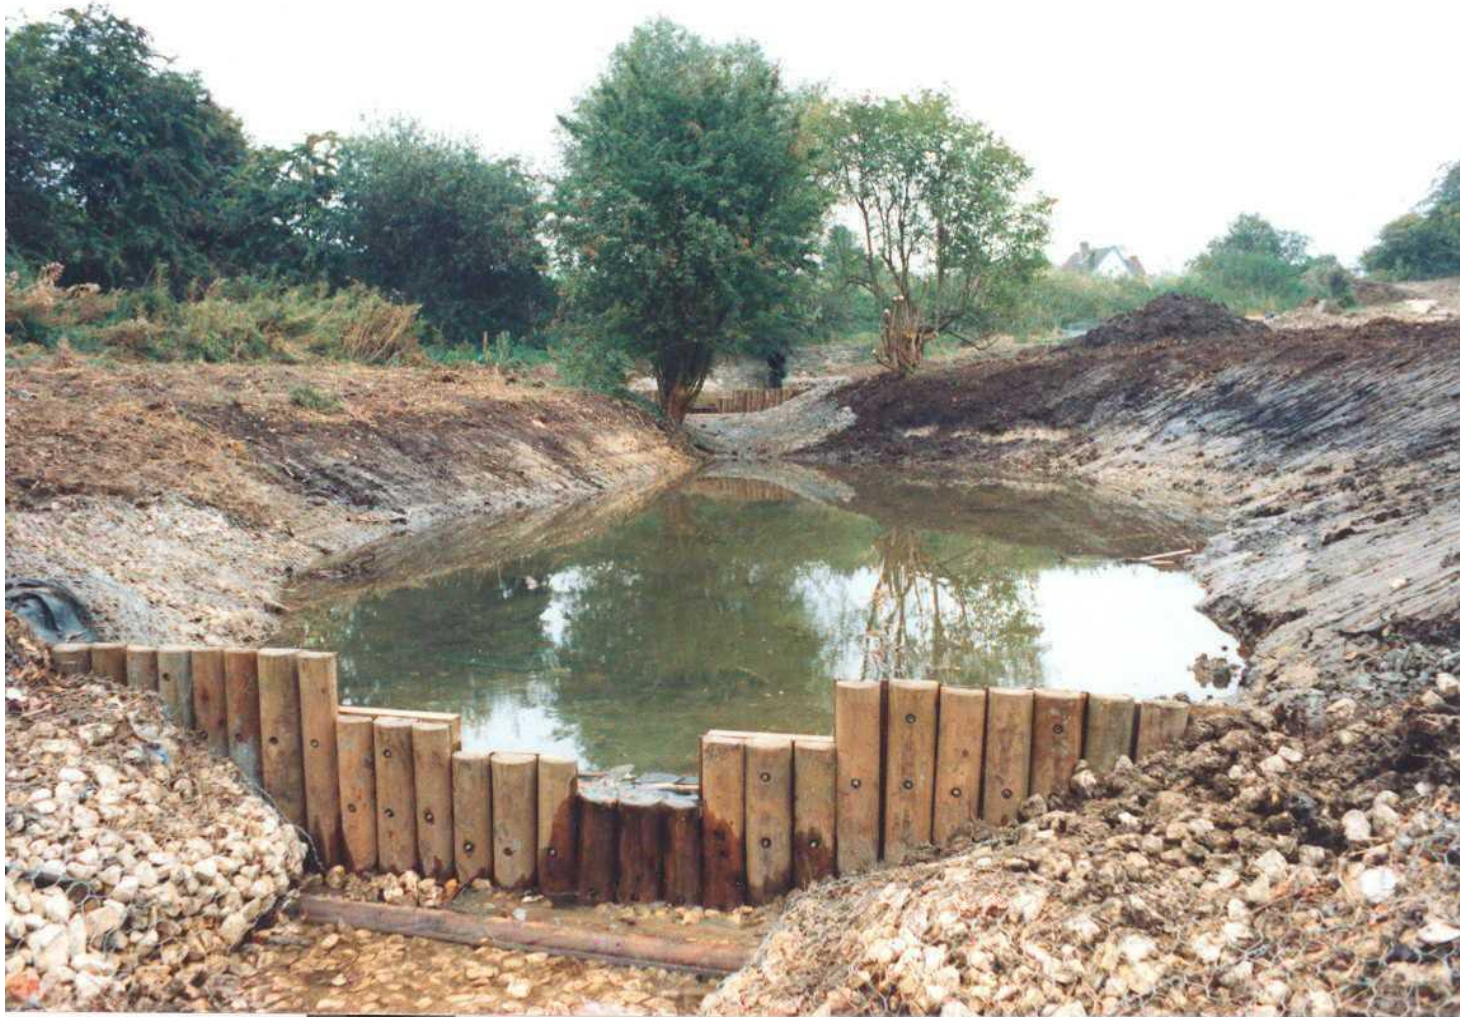
## Interception ponds with weirs dug at the valley head, 1988. The start of mitigation work TW funded

The ponds silted up, the limestone placed in the brook channel washed away, new solutions needed..

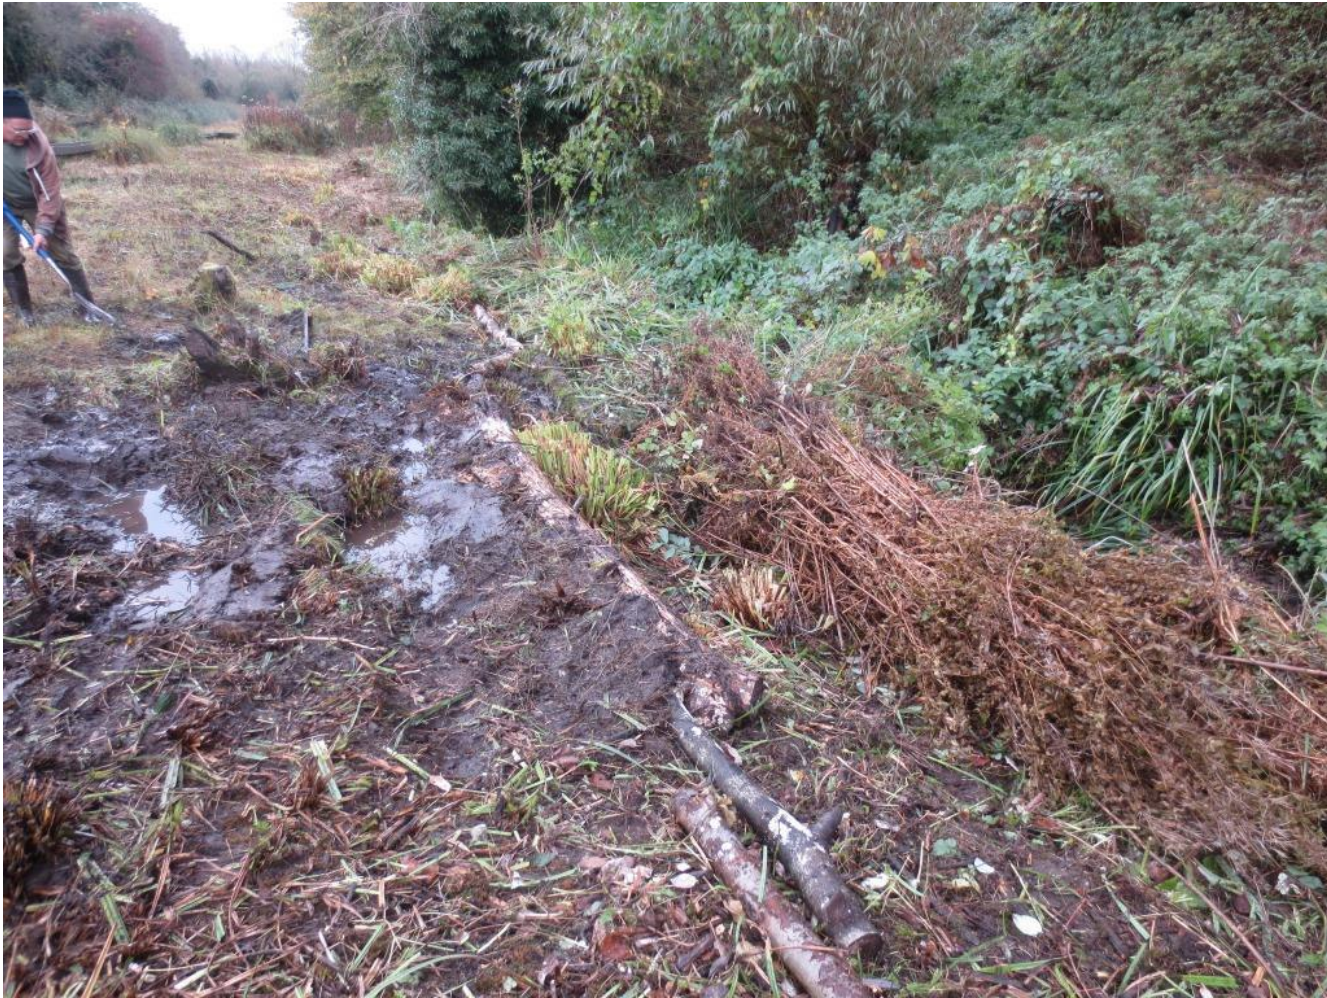
## FoLV work started on restricting spring water loss and re-wetting dry peat via small dams/bunds in 2016

A fen has to be wet. There were pipes draining the fen to the brook. First job was to dig out drainage pipes that had been under the old boardwalk.....with new boardwalk all can now go dry-footed through wetter fen

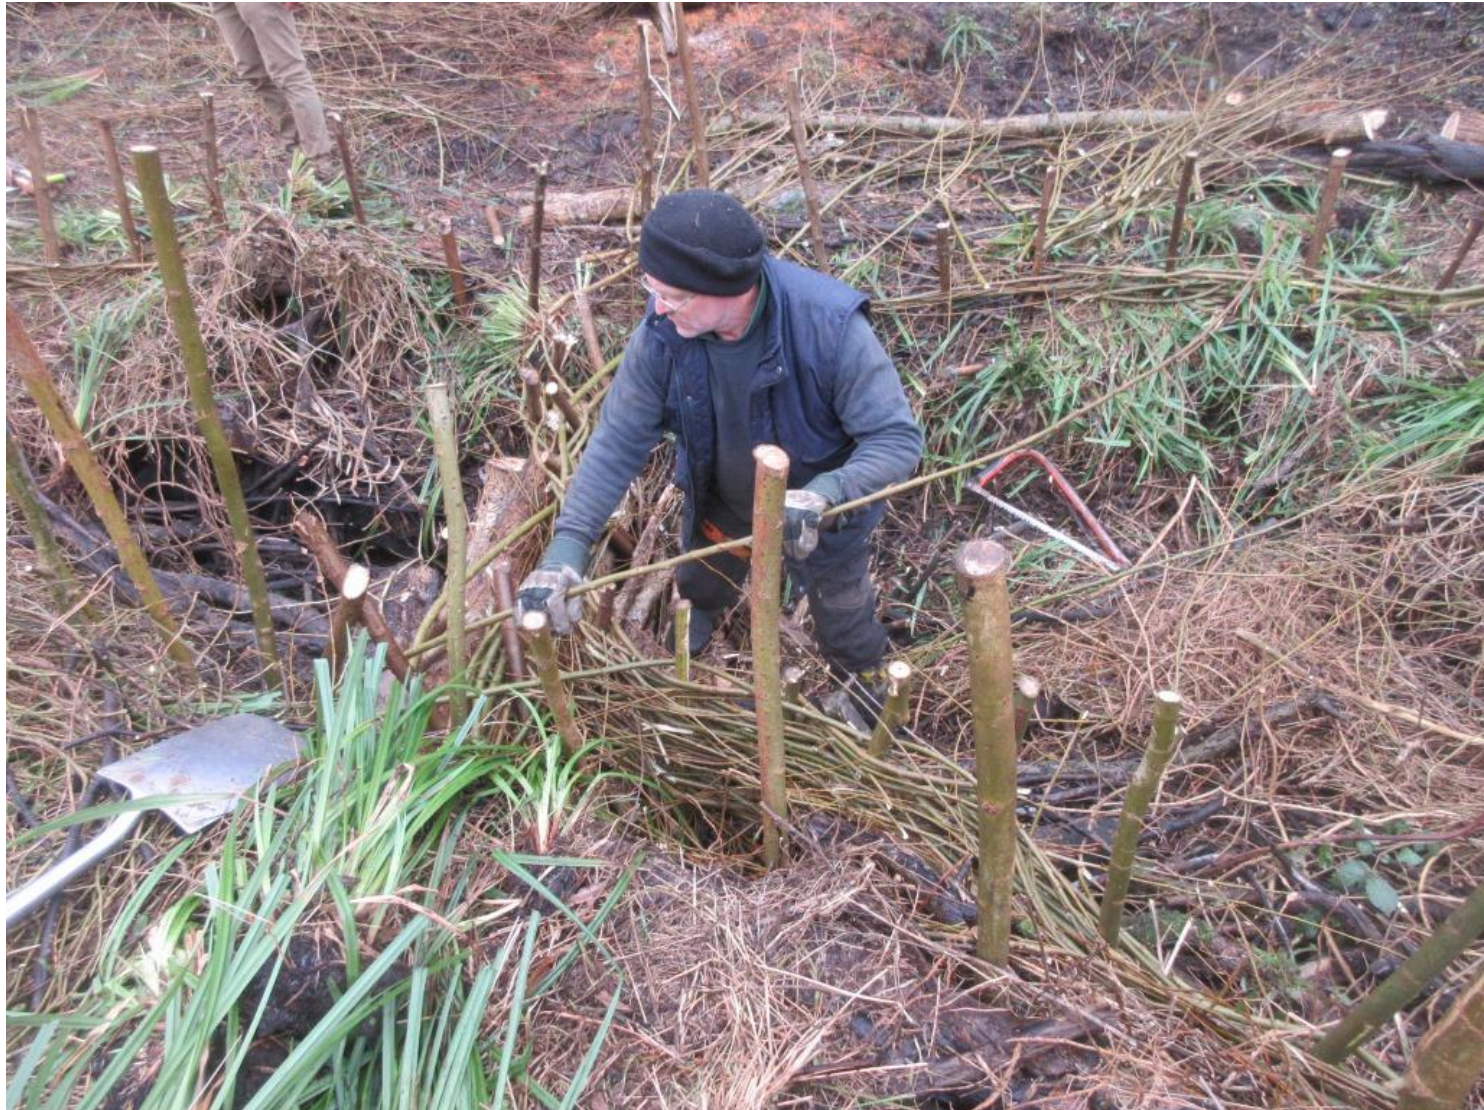
**The work uses  
natural materials  
available in Lye  
Valley like logs  
and willow  
coppice branches  
for weaving**

**Soft peat in the brook banks is protected from erosion by stakes driven in, woven hazel & willow barriers & fen cuttings are packed in behind**

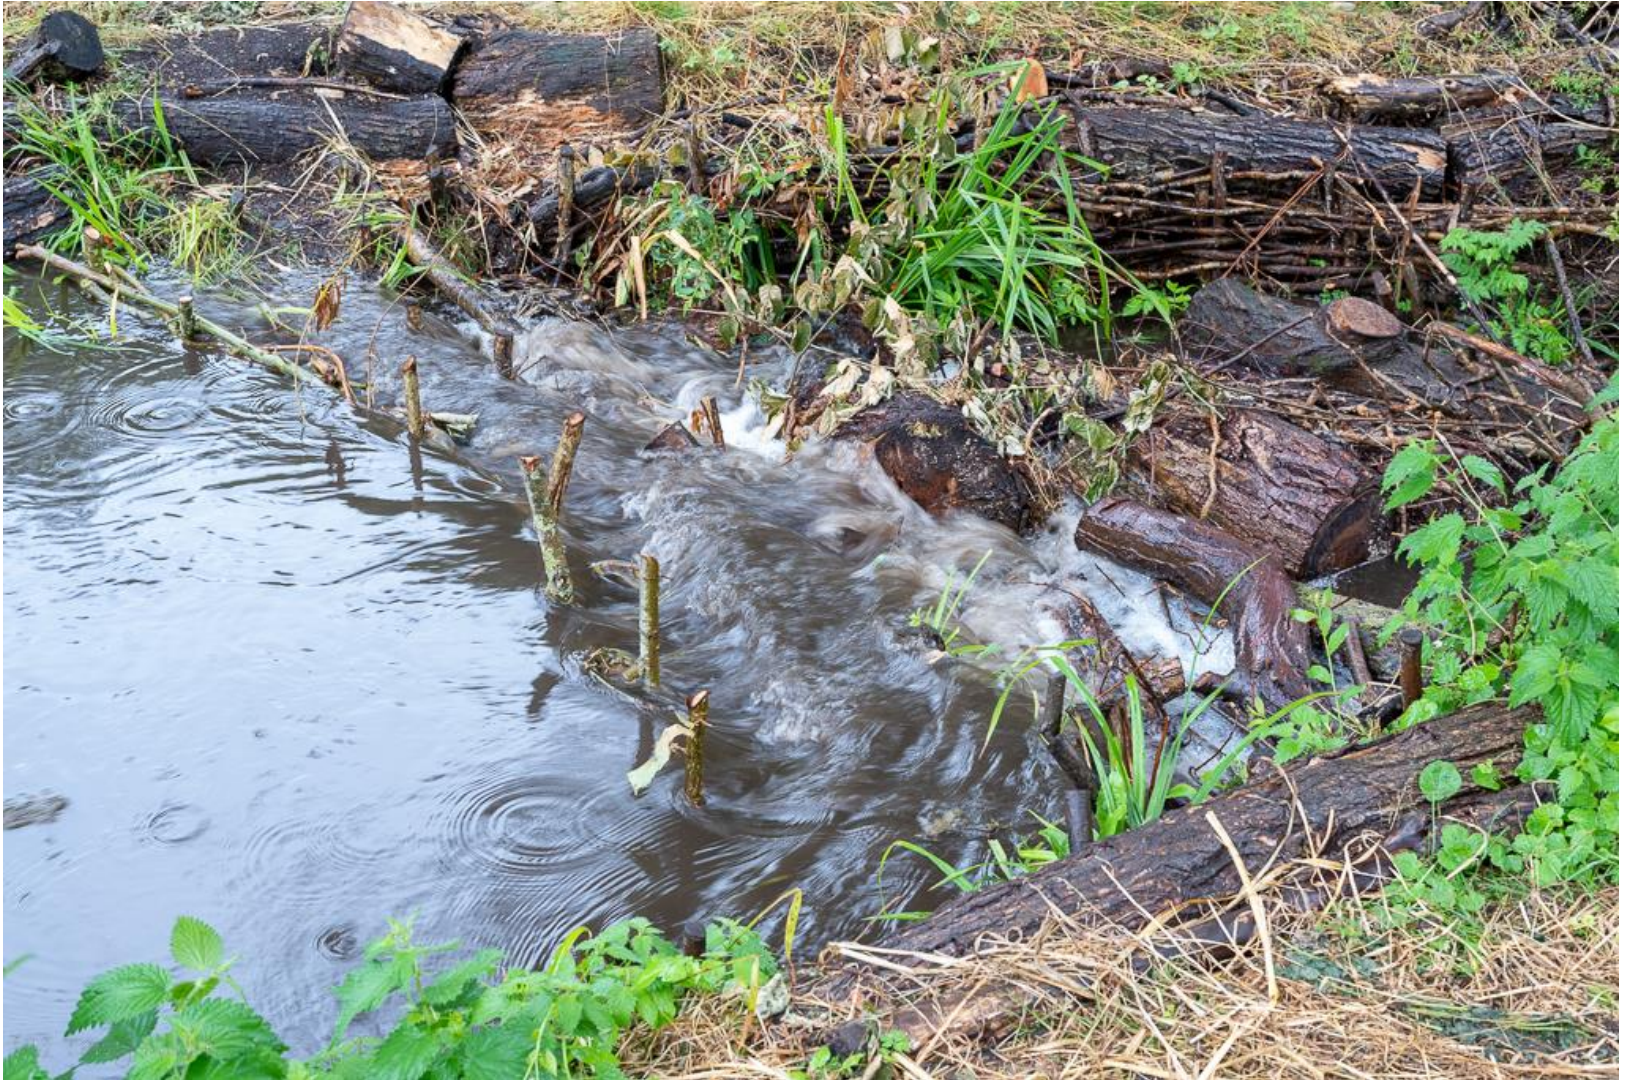
# Log dams work by slowing the flow and reducing the energy of the water

Not only the fen benefits, other effects lower down the watercourse.....

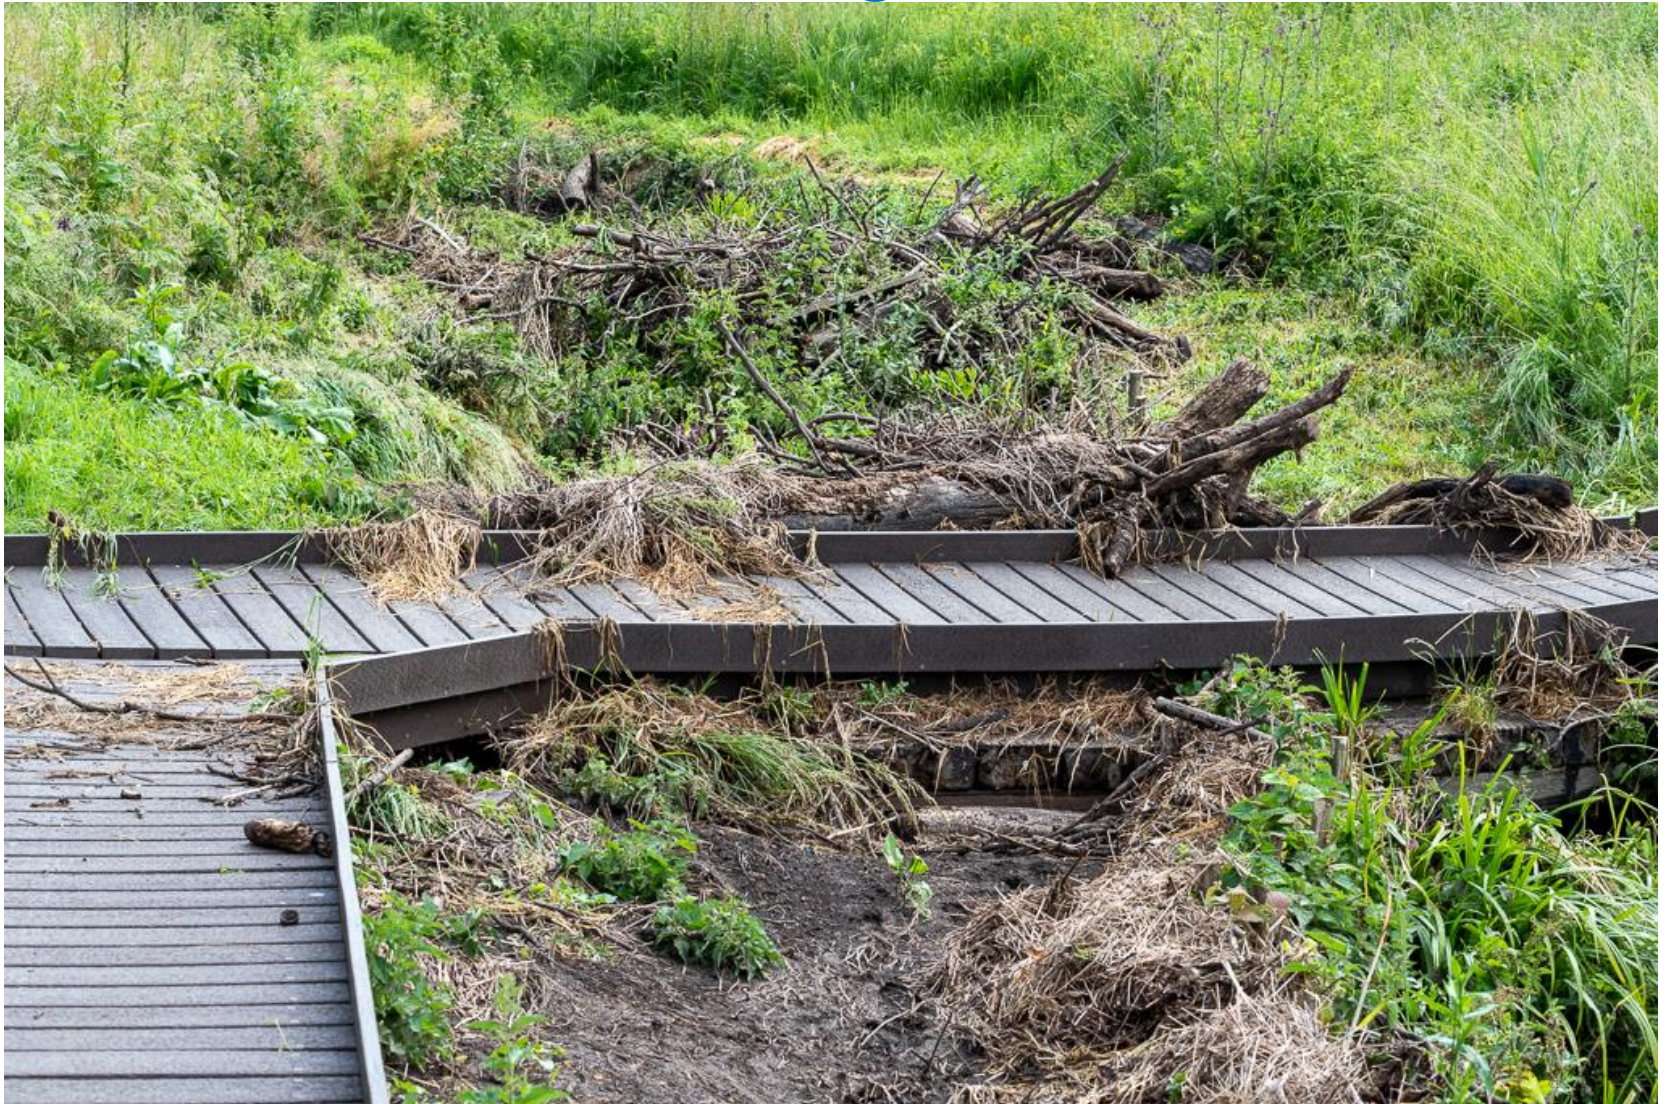
## Result of peak flash-flooding event after a fierce rain-storm on the morning of 20<sup>th</sup> June 2023

Flow had gone over bridge and undermined it. Piled cuttings washed out of bank in foreground and...
