# ***Flood Alleviation and Stopping Erosion in the Lye Valley***

**By Rod d'Ayala, for  
Friends of Lye Valley, July 2024**

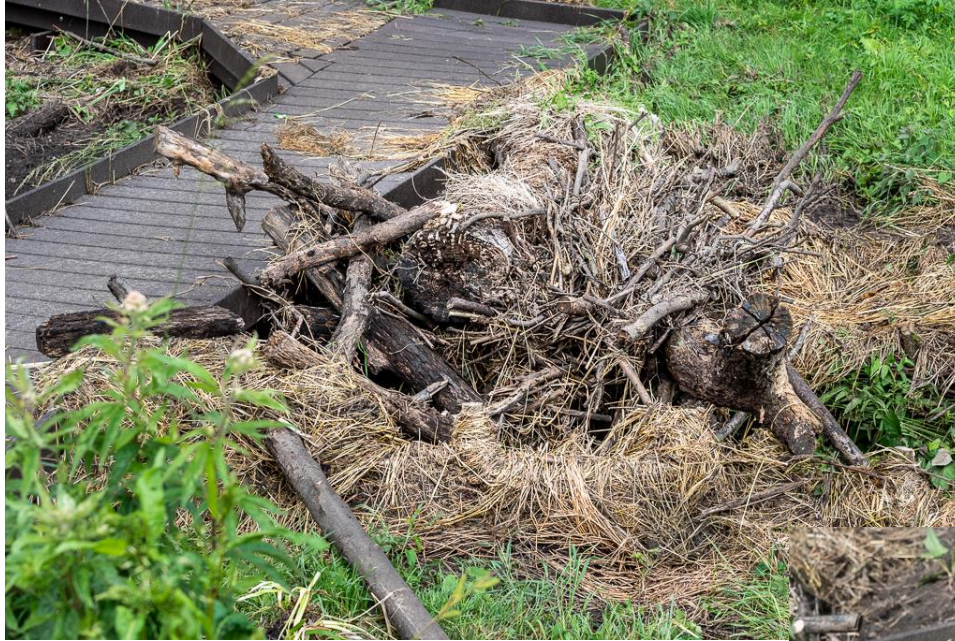
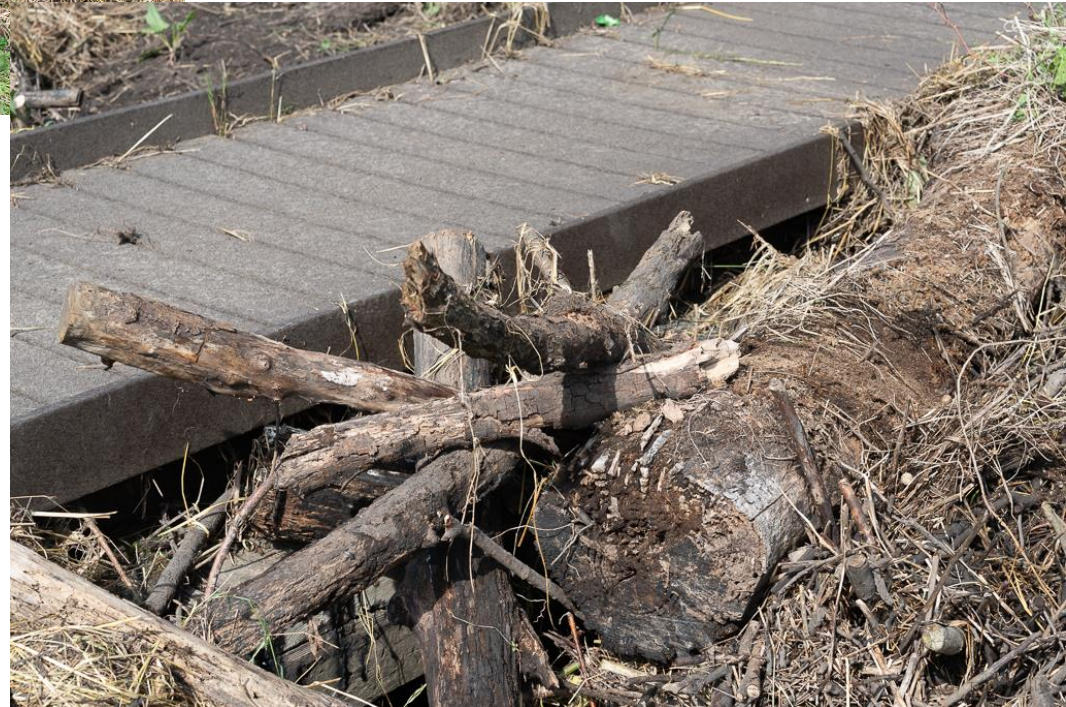
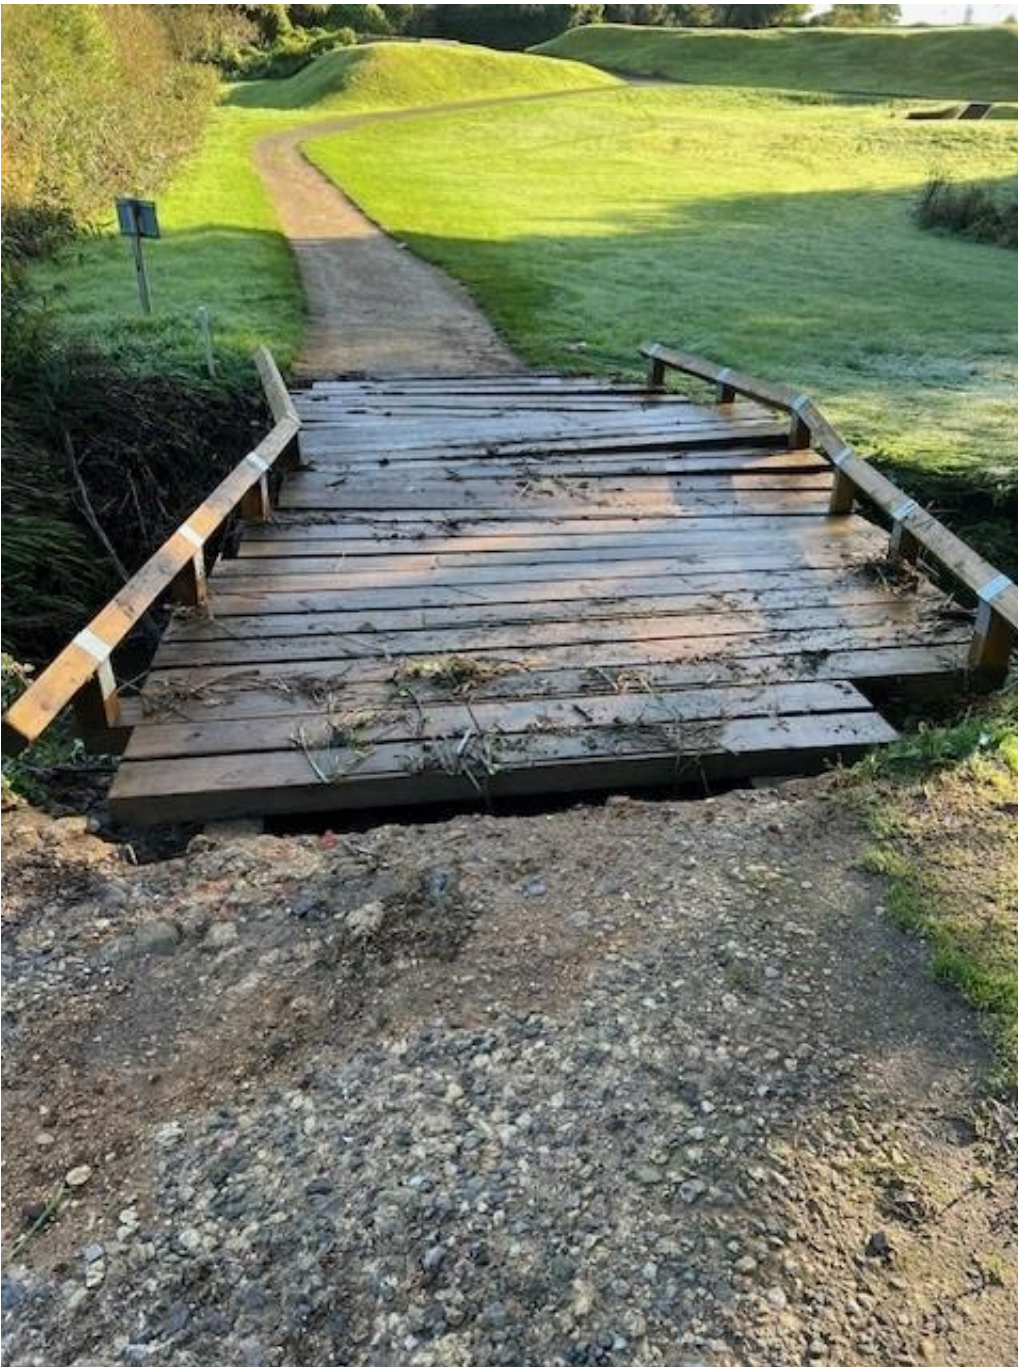
# Damage at the boardwalk bridge over the brook

Intensity of rainstorm resulted in a massive peak flow event (flash-flooding). These extreme events will be commoner

Log dams above bridge were broken & log & brash debris piled up against bridge and onto boardwalk

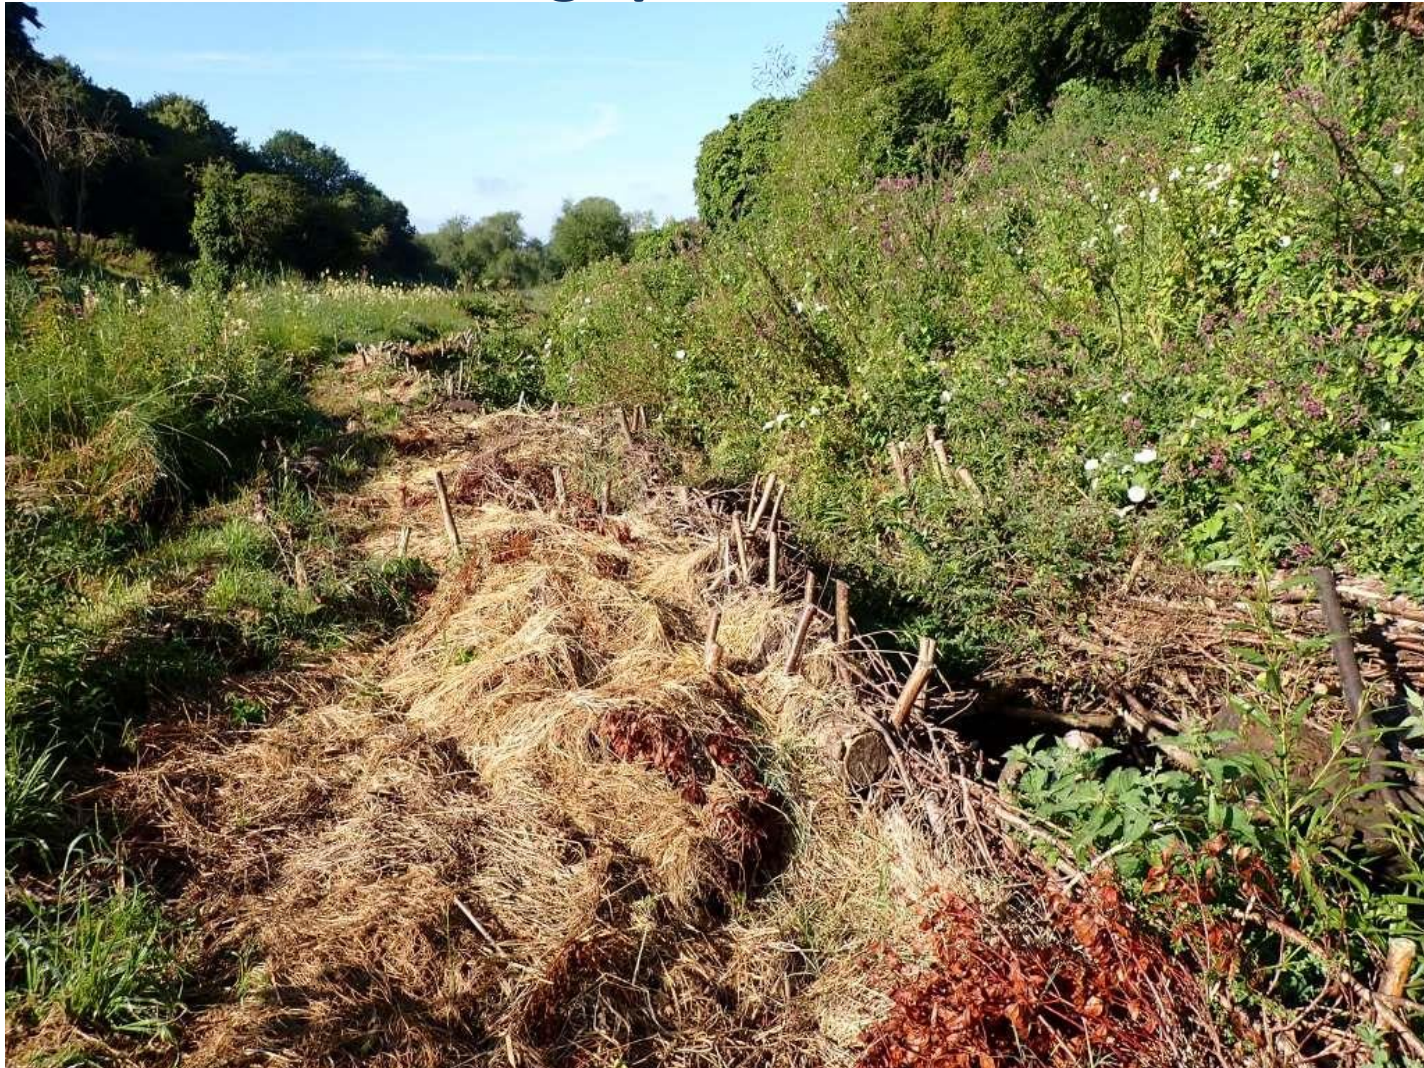
Now – new strategy involves more strengthening of bank defences, cuttings packed behind woven barriers

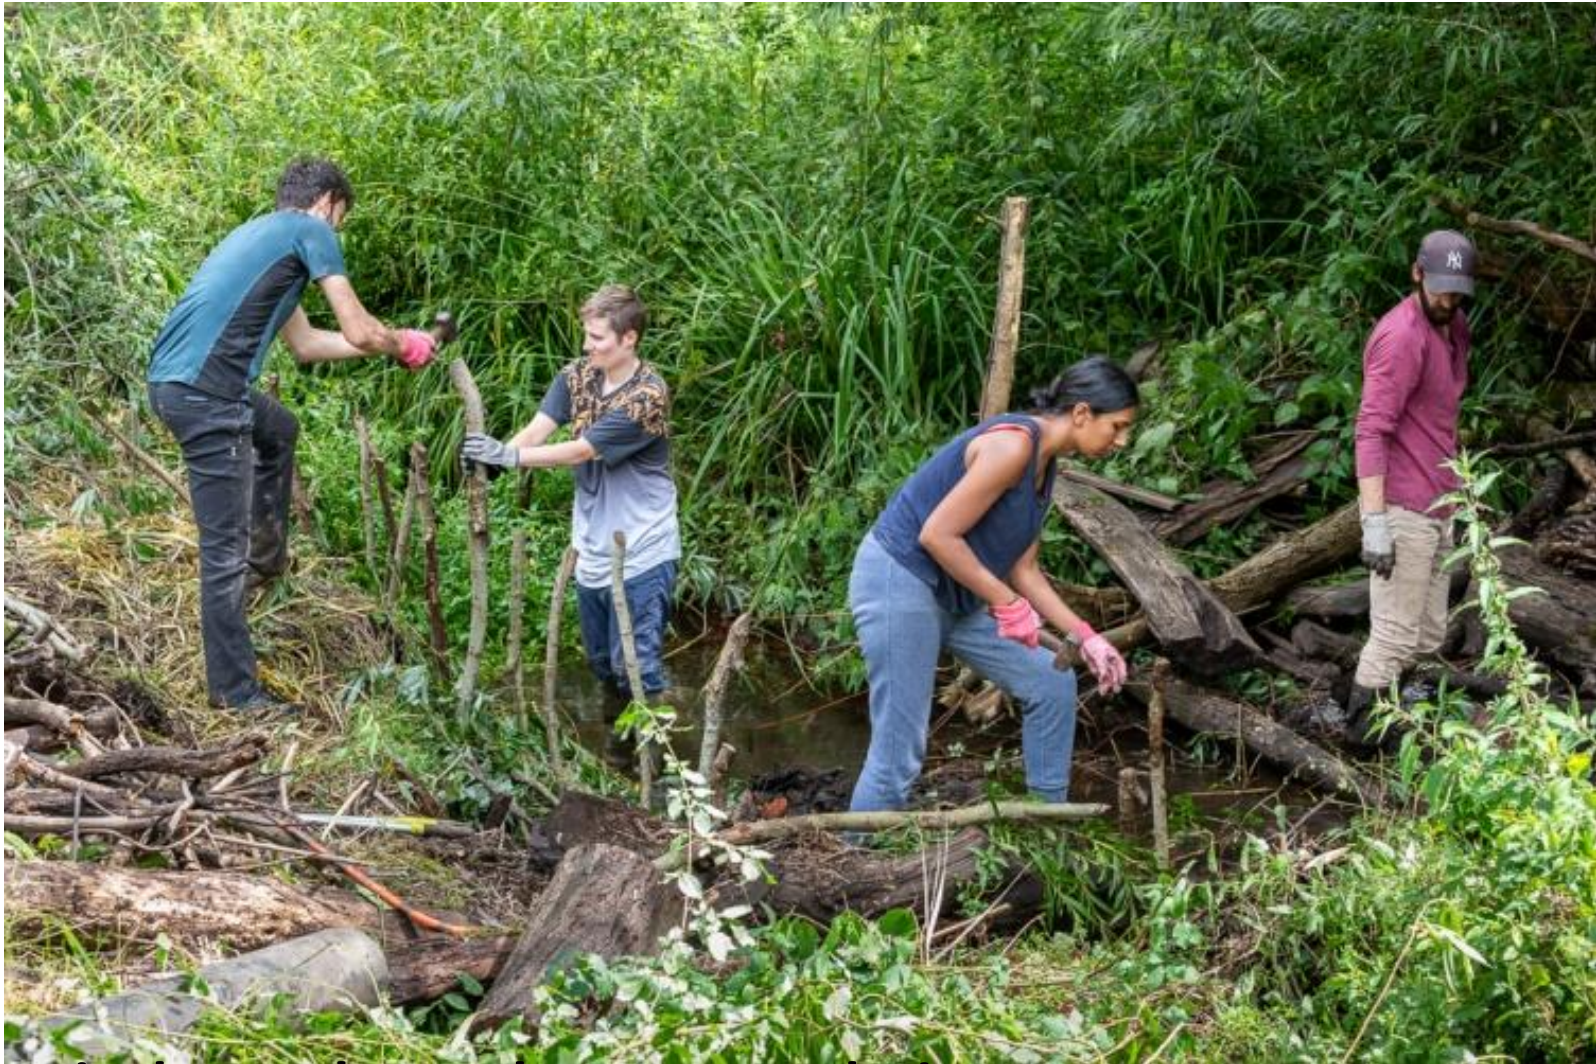
and **stronger (but leakier) log dams** across the channel, more water has to be let through, but still significantly slowed

**But constant repair and dam maintenance is still needed, using up volunteer time**

**But is there a better long term solution?** The peak flow needs reduction- see the '**Sponge Headington**' project
