# **Lye Valley: The Made-ground Bank to the east of the Warren Meadow off Warren Crescent.**

## **A study for Friends of Lye Valley (FoLV)**

J A Webb, February 2021

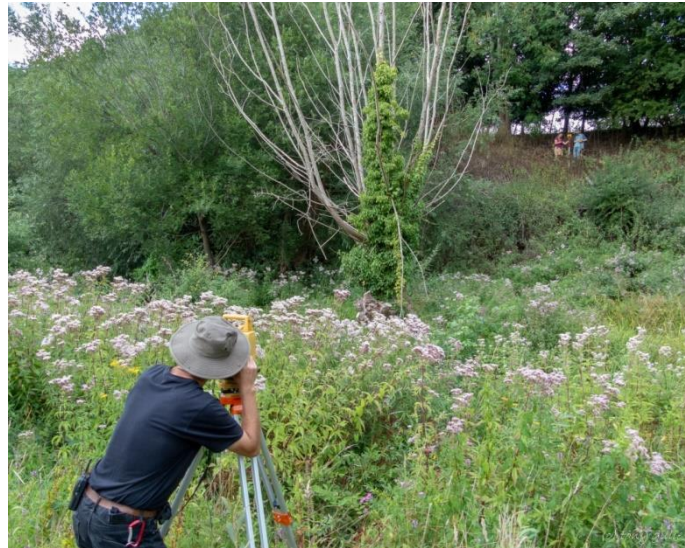
*Curt Lamberth surveys Warren Meadow embankment slope angle from the valley with help from FoLV volunteers on 01.08.2018. Photo Tony Gillie*
